SUMMARY REPORT

AmeriSpec Inspection Service
Tecumseh, Ontario
Ph#: (519) 739-1010 Fax#: (519) 739-1016

Doc #: 111921DC46

Dwelling Address: 5785 Mencarelli
Windsor, Ontario

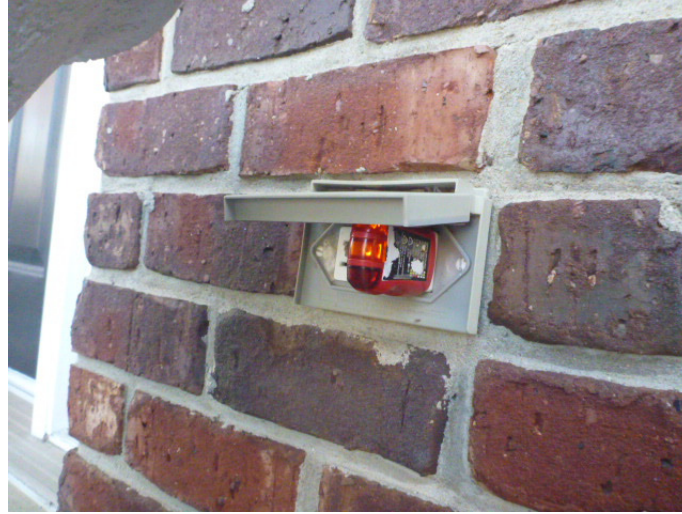
1109. Electrical

Review. GFCI located at exterior did not respond to test; suggest review by licensed electrician for repairs/replacement as needed for safety.

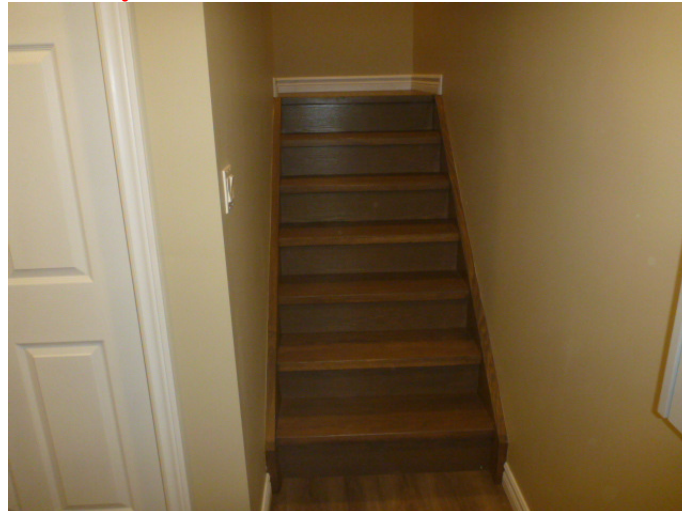
Review. No railings noted, recommend installing handrails for safety.

Step #	Component	Comment
1601.	Access	Finished areas in basement were observed. As these areas are not visible or accessible to the inspector they are excluded from this inspection.
1602.	Stairs	Review. No railings noted, recommend installing handrails for safety.
1603.	Floor	Serviceable.
1604.	Walls	Serviceable.
1605.	Ceiling	Serviceable.
1608.	Joists	Limited review due to finished basement.
1610.	Support Posts / Columns	Limited review due to finished basement.
1611.	Beams	Limited review due to finished basement.
1612.	Windows	Same type/material as house exterior windows, please refer to exterior step # 1105.
1613.	Heat / Cooling Source	Central heating/cooling.
1614.	Electrical	Serviceable.
1620.	Visible Plumbing	ABS; Kitec, pex.
1621.	Sump Pit	Submersible pump.

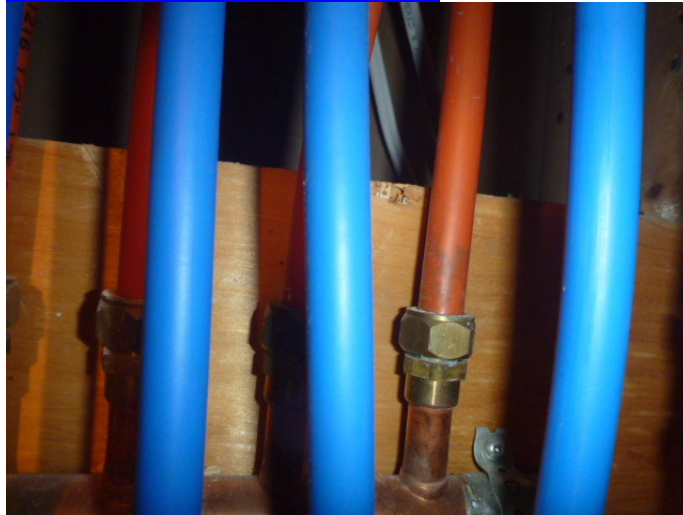
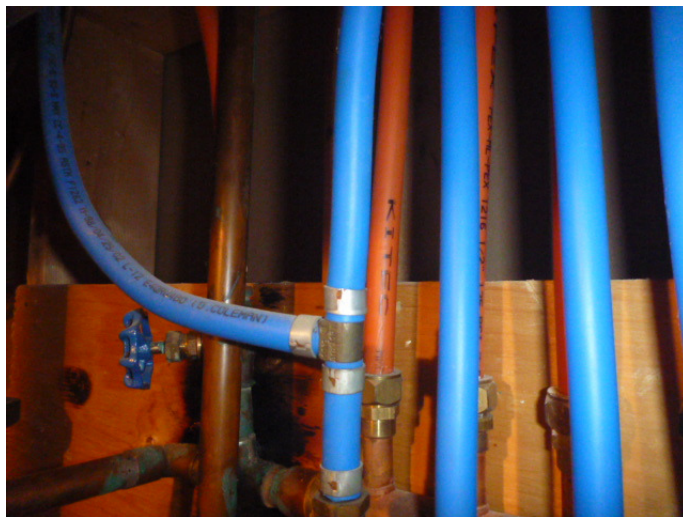
Review. Plumbing lines appear to be Kitec. This type of plumbing line may corrode and fail at the joints. Corrosion observed; no leaks visible at time of inspection. Recommend review by a licensed plumber for repair or replacement, as necessary. Visit this website for more information.

1702.	Supply Lines	Review. Pex; Kitec. Plumbing lines appear to be Kitec. This type of plumbing line may corrode and fail at the joints. Corrosion observed; no leaks visible at time of inspection. Recommend review by a licensed plumber for repair or replacement, as necessary. Visit this website for more information. http://www.kitecsettlement.com
1703.	Drain Waste Lines & Vent Pipes	ABS.
1705.	Sump Pump(s)	Located at the basement. Recommend a licensed plumber install a back up sump pump to prevent flooding during power outages.
1706.	Waste Disposal System	The waste disposal system appears to be connected to public sewer systems. Because of isolated instances where they system has not been connected to the public sewer system but remains an on-site system; client may wish to confirm sewer connection with the local building department or the property owner prior to closing.
1707.	Water Supply System	Water supply system appears to be public.

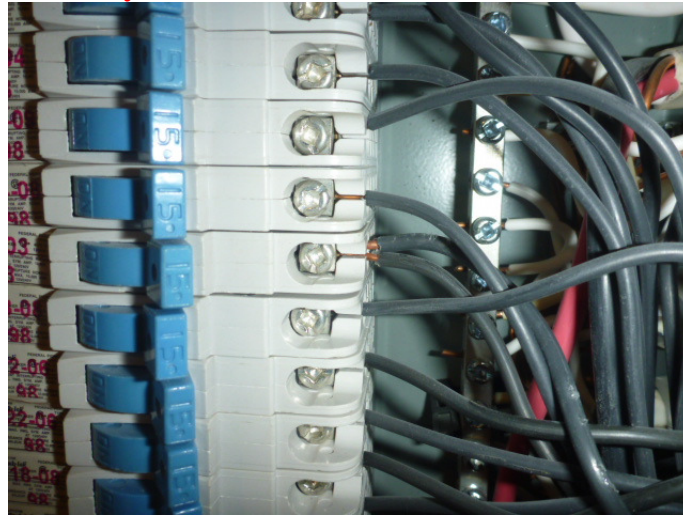
Review. Double tapping observed in main electrical panel. Double tapping (i.e. 2 wires on a single pole breaker) can add to the load of the affected circuit causing a possible overload and tripping breakers. We recommend review by a qualified professional electrician for repair or replacement as necessary.

1802.	Equipment Grounding Present	Yes.
1803.	Main Electrical Panel & Location	<p>Review. Branch circuit wiring is copper. Overload protection is provided by breakers.</p> <p>Double tapping observed in main electrical panel. Double tapping (i.e. 2 wires on a single pole breaker) can add to the load of the affected circuit causing a possible overload and tripping breakers. We recommend review by a qualified professional electrician for repair or replacement as necessary.</p>
1804.	Wiring Method	Romex.
1806.	Smoke Detectors	Periodic testing is suggested to ensure proper working order.
1807.	Service Amperage and Voltage	Service panel rating is approximately 125 amps and 120/240 volts.
