AmeriSpec Inspection Service
Tecumseh, Ontario
Ph#: (519) 739-1010 Fax#: (519) 739-1016

Doc #: 112221DC50 Inspector: Donald Campbell
Date: 11/22/2021
Dwelling Address: 3071 Centennial
Windsor, Ontario

AmeriSpec General Home Inspection**GENERAL CONDITIONS**

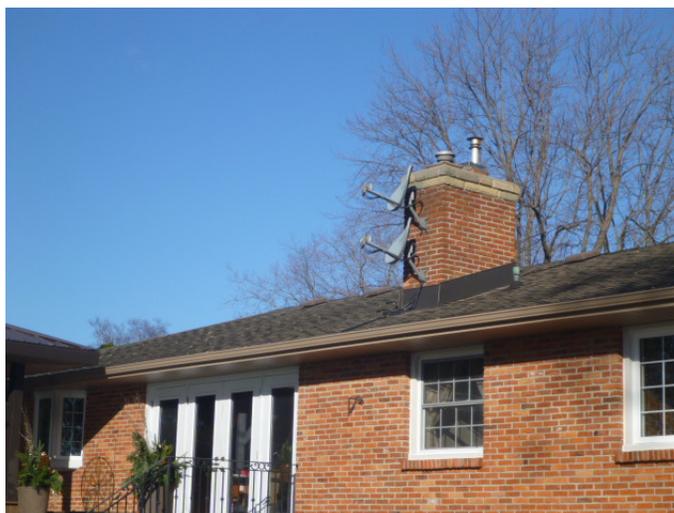
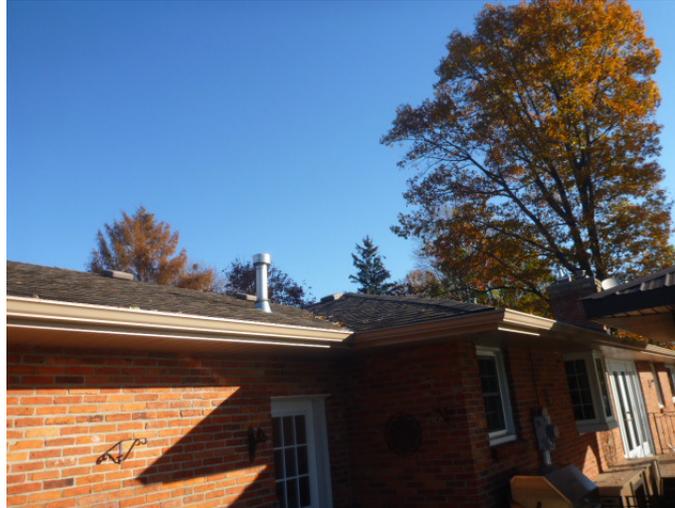
Step #	Component	Comment
1201.	Methods Used To Inspect	The roof was inspected from the ground.
1202.	Material/Type	Asphalt composition shingle.
1203.	Exposed Flashings	Recommend re-sealing all flashings and through the roof vents as a part of routine maintenance.
1205.	Conditions	Roof shows normal wear for its age and type. No damaged, deteriorated, or missing roofing materials were observed; it appears to be in serviceable condition at time of inspection.

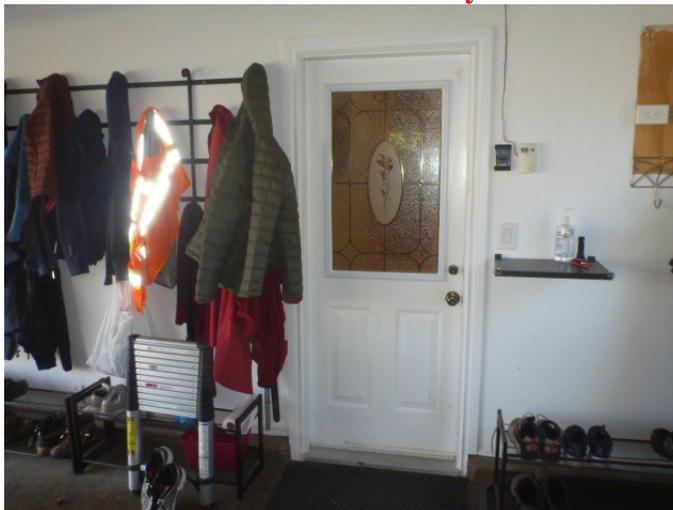
1311. Fire Door **Review. No self-closer observed. Suggest installing self-closer as a safety measure. Recommend installing a solid-core fire rated door for safety.**

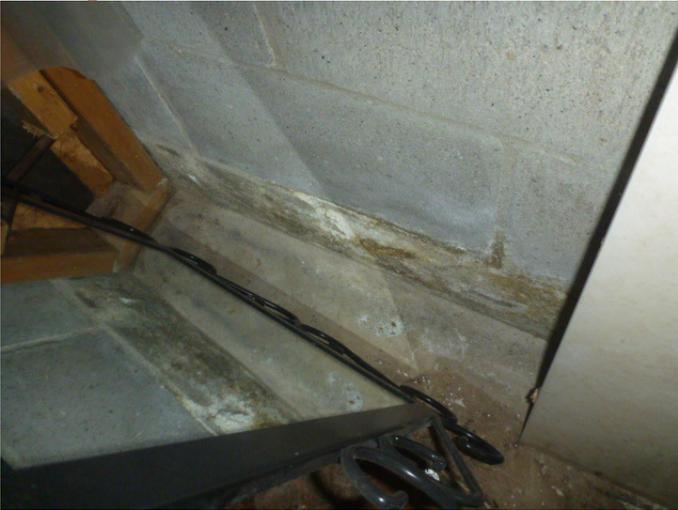
Step #	Component	Comment
1601.	Access	Finished areas in basement were observed. As these areas are not visible or accessible to the inspector they are excluded from this inspection.
1602.	Stairs	Serviceable.
1603.	Floor	Serviceable.
1604.	Walls	Review. Efflorescence observed at walls; this is a mineral deposit left behind from exterior water infiltration, recommend maintaining a positive grade away from the foundation and further extending downspouts to limit further moisture intrusion.

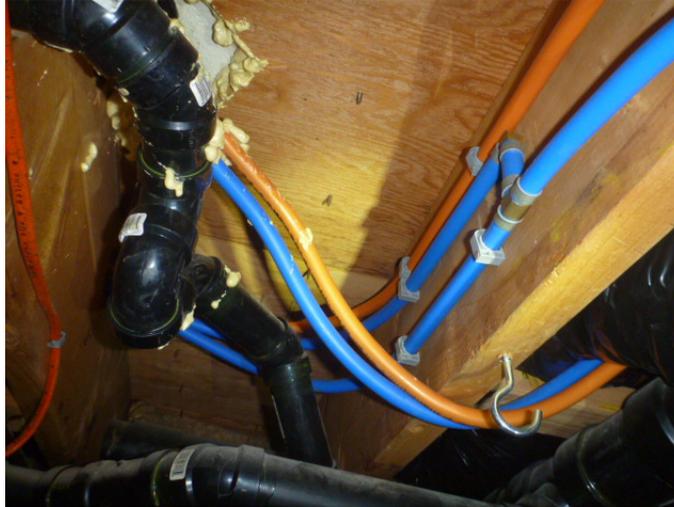
1702. Supply Lines **Review. Copper; Pex. Some of the plumbing lines appear to be Kitec. This type of plumbing line may corrode and fail at the joints. No leaks visible at time of inspection. Recommend monitoring for future corrosion and leaks and repairs as necessary.**
