**AmeriSpec Inspection Service**  
Tecumseh, Ontario  
Ph#: (519) 739-1010 Fax#: (519) 739-1016

Doc #: 051723DC23 Inspector: Donald Campbell  
Date: 5/16/2023  
Dwelling Address: 170 Pentilly  
Tecumseh, ON

## AmeriSpec General Home Inspection

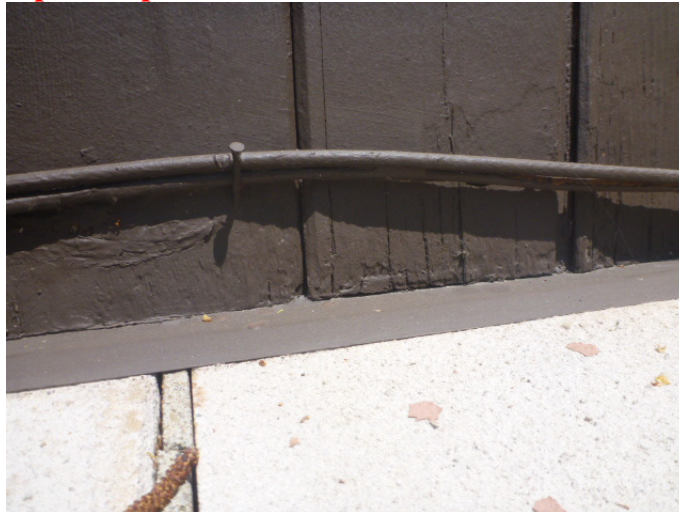
Step #	Component	Comment
1101.	Driveway	Concrete. Common cracks observed, primarily a cosmetic concern. We suggest sealing all cracks in concrete/brick surfaces to prevent water penetration as a routine maintenance effort.
1102.	Walkways	Concrete; Brick.
1103.	Exterior Wall Cladding	<b>Review. Brick veneer; Wood siding. Wood deterioration observed at the exterior wood siding. Suggest repairs/replacement as needed.</b>

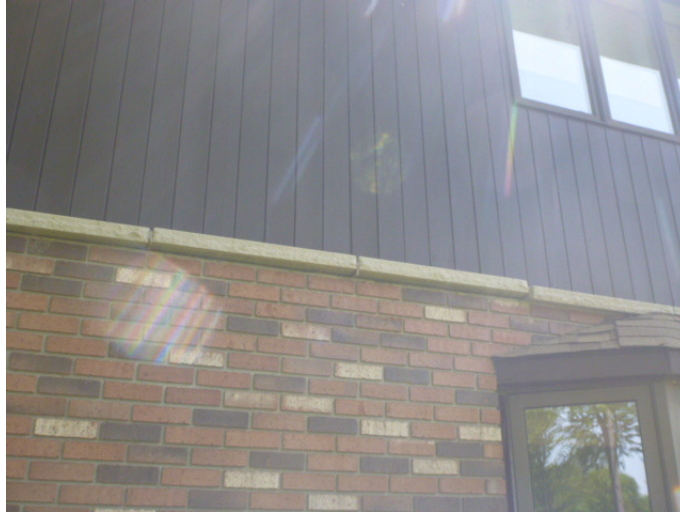
1104. Trim

**Review. Loose lintels noted, suggest review for repairs as necessary.**

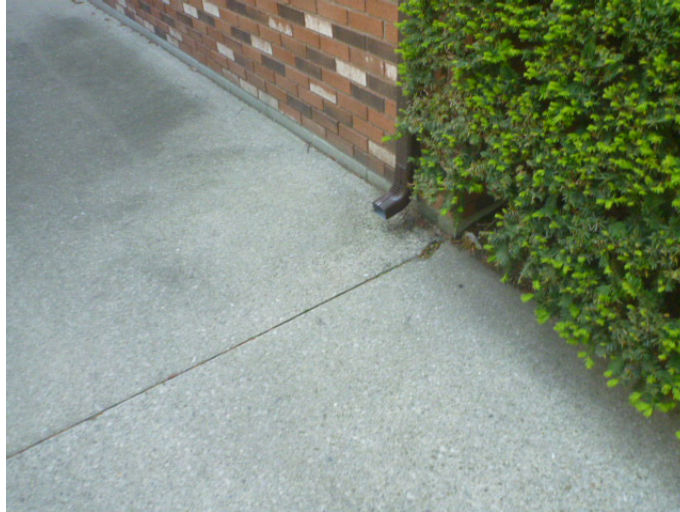
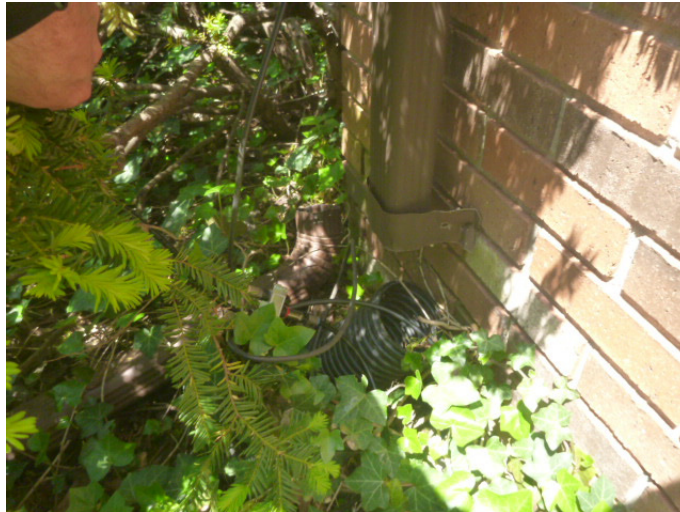
1107. Gutters /  
Downspouts

**Review. Suggest installing extensions to gutter system to ensure proper drainage away from foundation.**

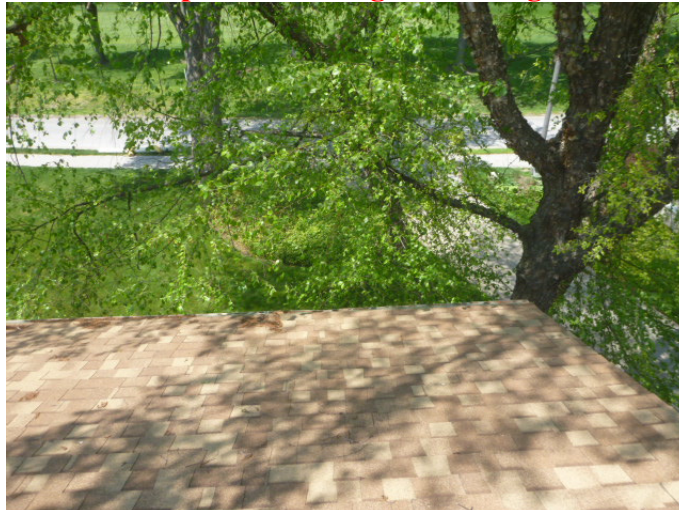
1206. Maintenance

**Review. Suggest trimming all trees and vegetation away from roof to prevent damage to roofing materials.**

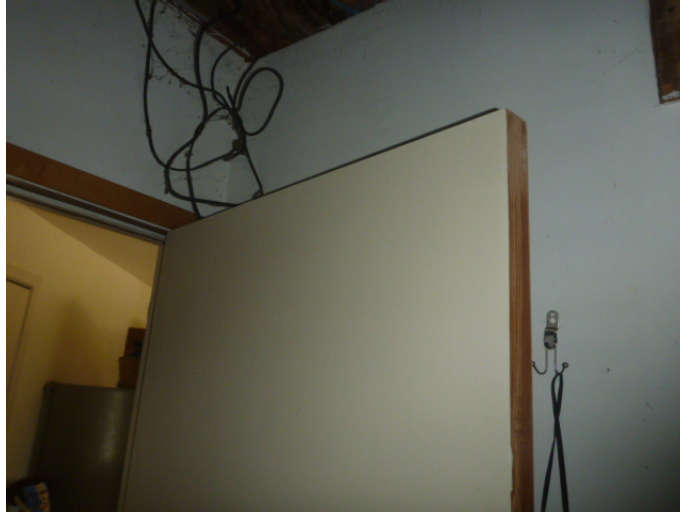
1311. Fire Door

**Review. No self-closer observed. Suggest installing self-closer as a safety measure.**

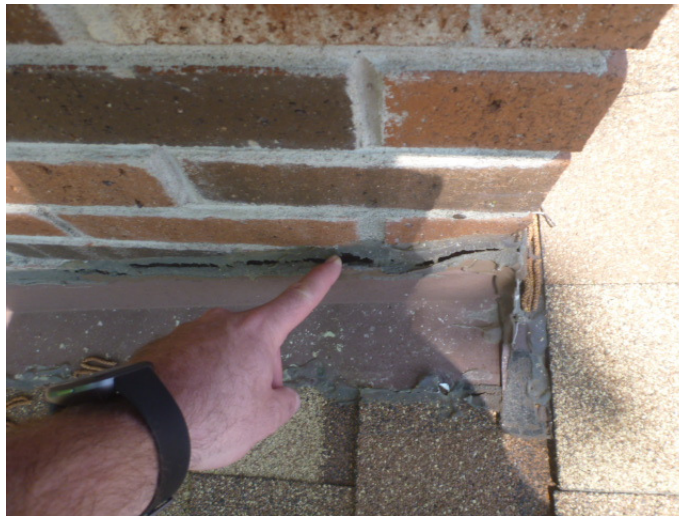
Step #	Component	Comment
1401.	Chimney Type	Masonry chimney.
1402.	Visible Condition	Suggest sealing chimney cap (chimney crown) to reduce opportunity for water infiltration and damage. This is a common maintenance item that is often neglected by homeowners; you should make a crown inspection part of your routine seasonal maintenance checklist.
1403.	Chimney Flue	Clay.
1404.	Flashings	<b>Review. Re-seal as routine maintenance to ensure leak free conditions.</b>

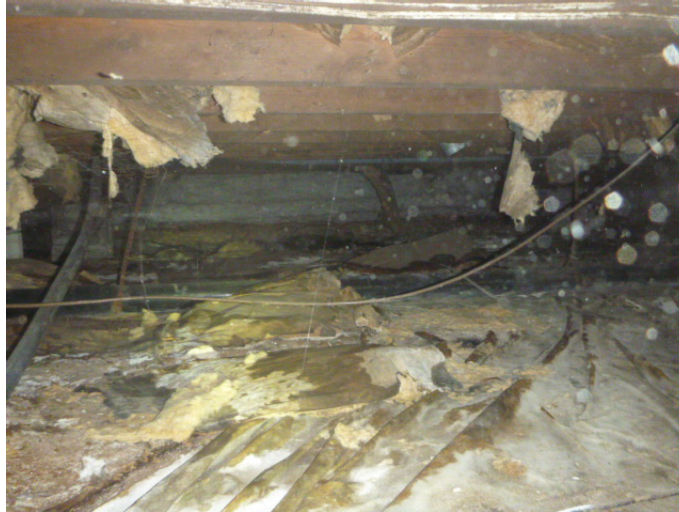
<b>Step #</b>	<b>Component</b>	<b>Comment</b>
1502.	Floor	<b>Review. Dirt. Damp at time of inspection. Suggest extending downspouts and re-grading at exterior to limit further moisture intrusion into the crawlspace.</b>

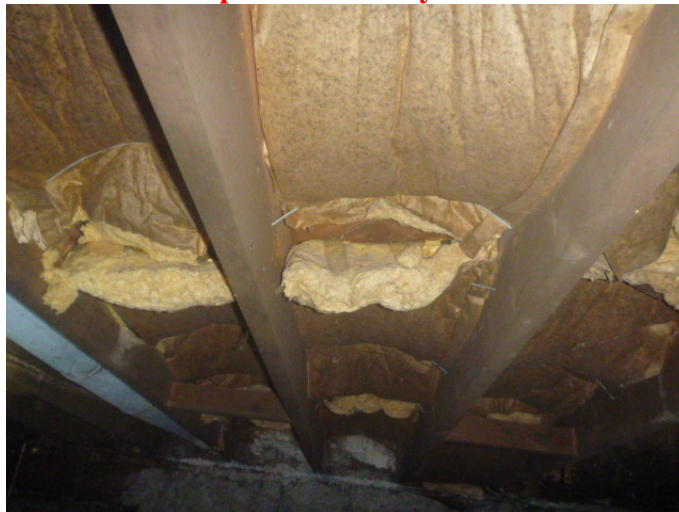
1503.	Walls	Suggest insulating exterior walls to improve efficiency.
1504.	Joists	Wood.
1506.	Support Posts / Columns	Concrete blocks.
1507.	Beams	Wood.
1508.	Electrical	Not Inspected.
1510.	Insulation	<b>Insulation installed on unfinished ceiling in a heated crawlspace is generally unnecessary and does not result in any measurable energy savings. Suggest removing insulation to improve efficiency.</b>

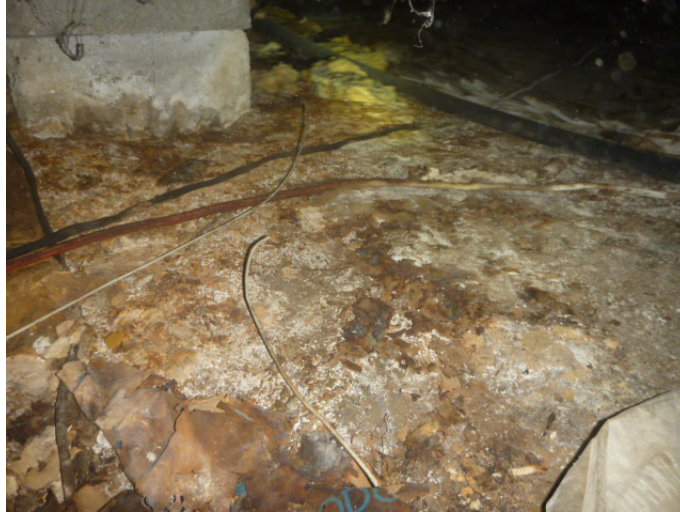
1511. Moisture  
Barrier

**Review. No moisture barrier observed. Moisture barriers may not have been required at the time the home was built. Due to moisture problems observed, we suggest installation of a moisture barrier to prevent any future/further damage/deterioration to the structure and to ensure a dry clean crawlspace.**

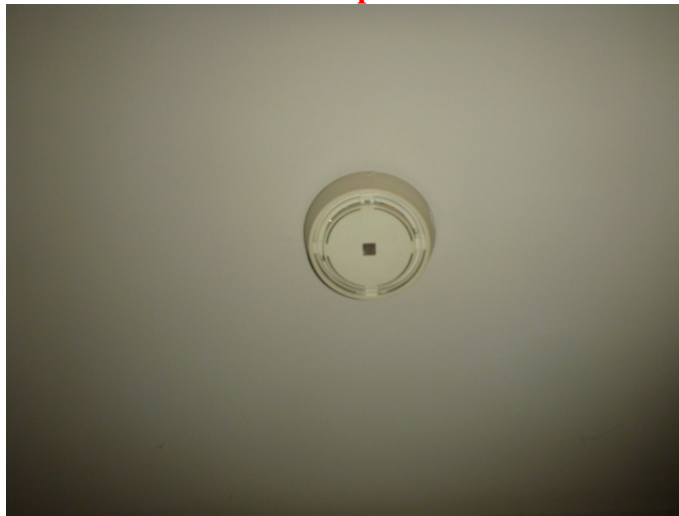
Step #	Component	Comment
1801.	Electrical Main Service	Service entrance is underground.
1803.	Main Electrical Panel & Location	Overload protection is provided by breakers.
1804.	Wiring Method	Romex.
1806.	Smoke Detectors	<b>Review. In the inspectors opinion the smoke detector(s) are near the end of their useful life due to age and condition. Recommend replacement to ensure safety.</b>

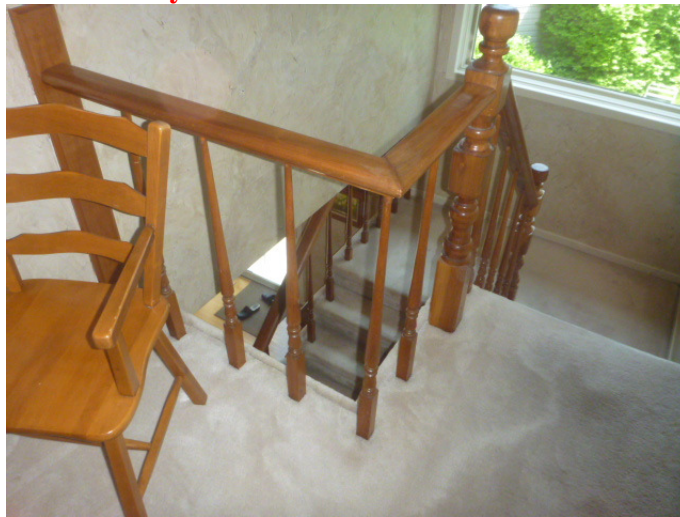
2603.	Ceilings	Serviceable.
2604.	Doors	Serviceable.
2605.	Closet / Wardrobe	Serviceable.
2606.	Windows	Same type/material as house exterior windows, please refer to exterior step # 1105.
2607.	Heat / Cooling Source	Central heating/cooling.
2608.	Electrical	Serviceable.
2609.	Stairs	<b>Review. Spacing between guardrails appears larger than 4 inches which may allow small children to crawl through the space. Client may wish to reduce spacing as a child safety enhancement.</b>

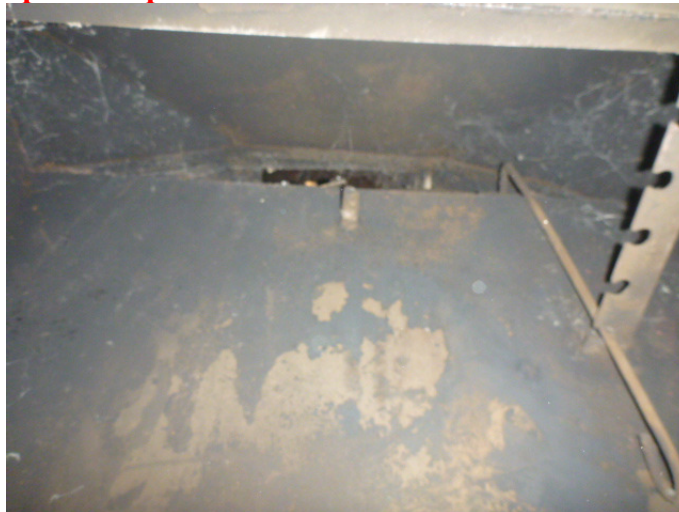
Step #	Component	Comment
2661.	Floors	Serviceable.
2662.	Walls	Serviceable.
2663.	Ceilings	Serviceable.
2666.	Windows	Same type/material as house exterior windows, please refer to exterior step # 1105.
2667.	Heat / Cooling Source	Central heating/cooling.
2668.	Electrical	Serviceable.
2670.	Fireplace	<b>Review. Creosote build up was observed. Creosote is a naturally produced flammable by-product of combustion. We suggest having cleaned and inspected by a fireplace and chimney specialist to assure safe operation prior to use.</b>

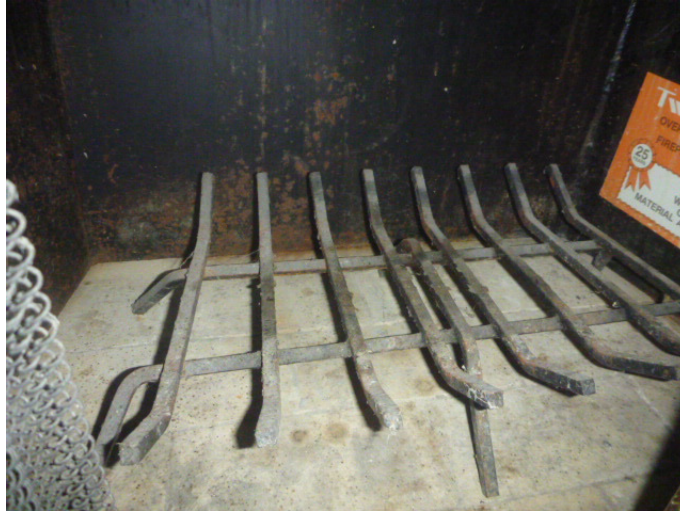
Step #	Component	Comment
2681.	Floors	Serviceable.
2682.	Walls	Serviceable.
2683.	Ceilings	Serviceable.
2684.	Doors	Serviceable.
2685.	Closet / Wardrobe	Serviceable.
2686.	Windows	Same type/material as house exterior windows, please refer to exterior step # 1105.
2687.	Heat / Cooling Source	Central heating/cooling.
2688.	Electrical	Serviceable.
2689.	Fireplace	<b>Review. A fireplace insert was observed in the fireplace. We cannot determine by a visual inspection if this system was installed according to manufacturers' specifications or local building authority requirements. Inserts, flues, and flue liners are not visible or accessible for examination unless the insert is removed. Due to safety concerns regarding dirty flues, cracks, damaged and/or deteriorating flues and chimney on fireplaces, fireplace appears to have been never been used. We suggest a complete review of the fireplace and flue by a qualified licensed chimney specialist prior to closing to ensure fire safety.</b>
