# Inspection Report

867 Langlois  
Windsor ON

**Mailloux Home Inspections**

<b>Date:</b> 2020-02-13	<b>Time:</b> 2:00	<b>Report ID:</b> 021301
<b>Property:</b> 867 Langlois Windsor ON	<b>Customer:</b> Kashif Yousuf	<b>Real Estate Professional:</b>

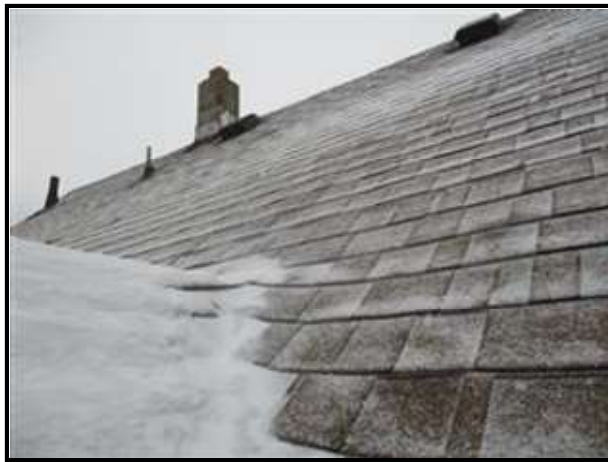
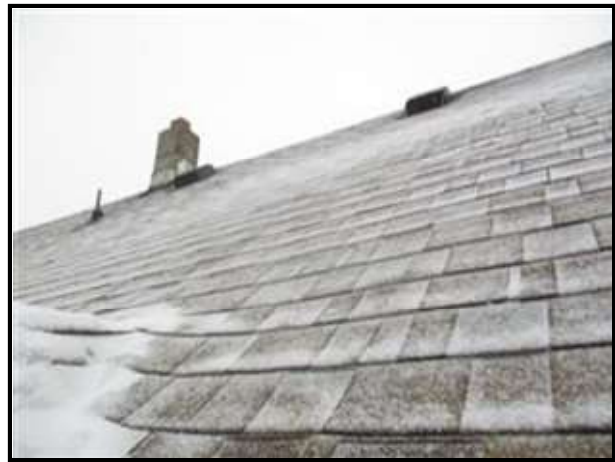
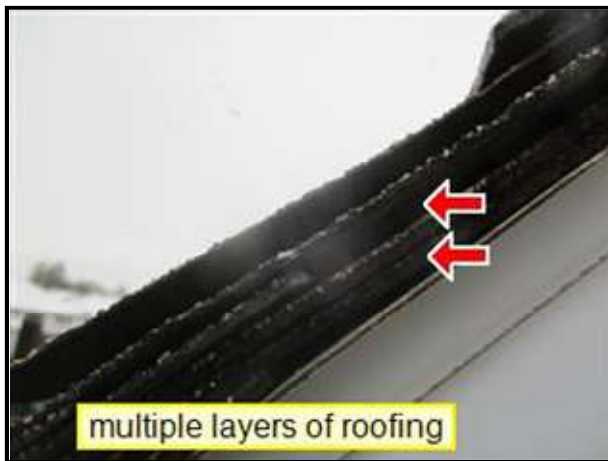
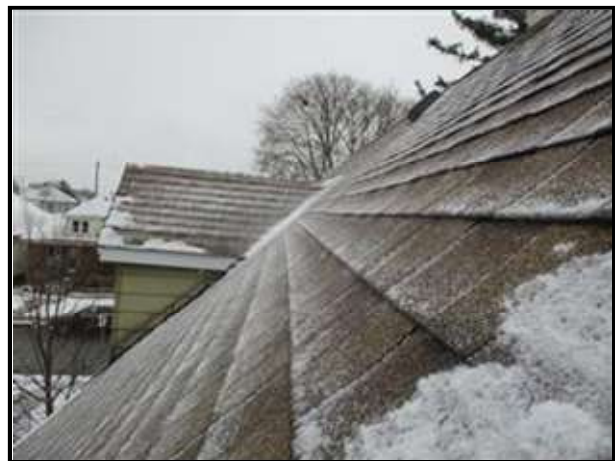
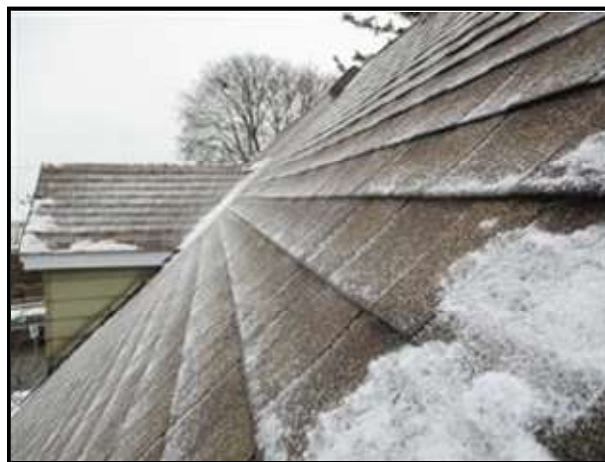
**1.0** (1) Snow covered and not visible at time of inspection. Inspection was limited to viewing from various places while on a ladder. Areas that were cleared away, showed no defects and were in the age group indicated above. Entire roof should be inspected when clear of snow.

(2) Multiple layers noted. Stripping will be required when re-roofing. Flashings (if present) are mainly below top roofing layer and could not be fully inspected. Normally the roofing material will not last as long when applied as a second layer.

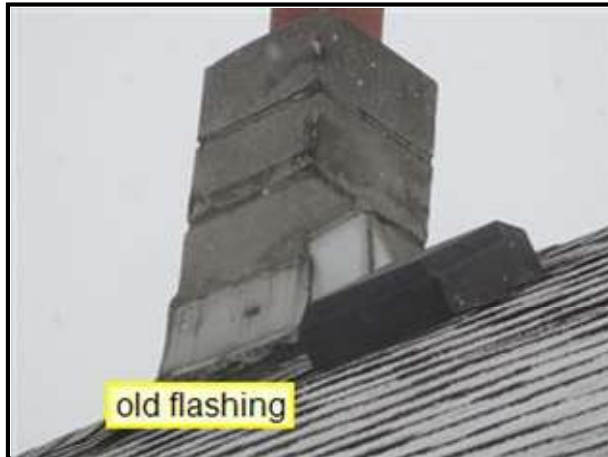
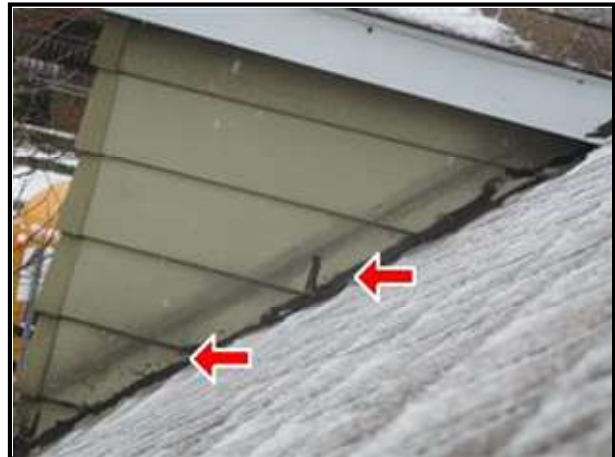
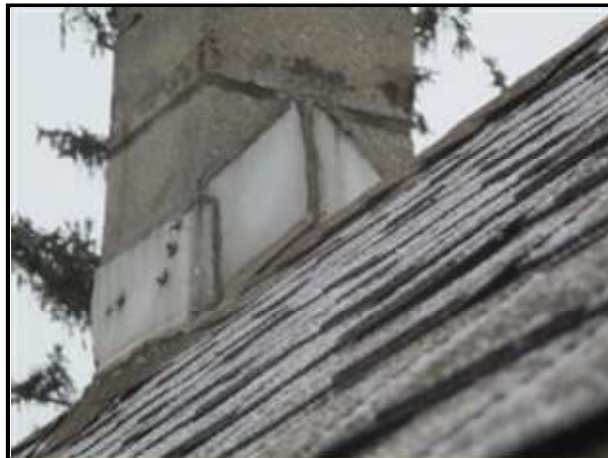
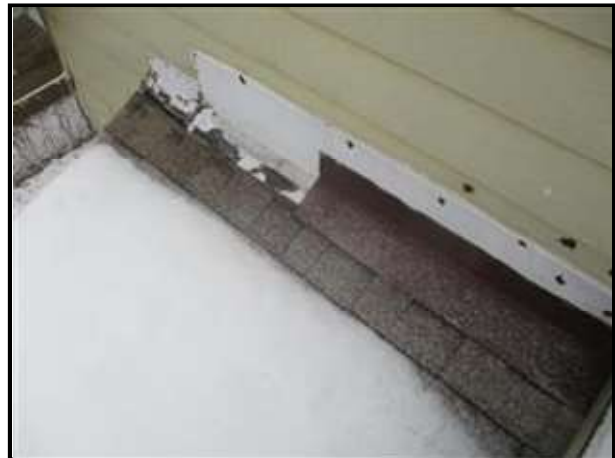
**1.1** (1) Old flashing was kept in place at last re-roofing. This older material will be more prone to leakage and periodic review and maintenance is required. Roofing cement is used to correct flashing leaks, but should be considered as a short term solution. New flashing may be required if leakage becomes an issue or at the time of the next re-roofing.

(2) While there were no visible defects, initial roof leaks and/or recurring roof leakage problems are often due to inadequate or damaged flashing. Ensure all flashings at chimneys, rooftop vents and plumbing stacks are checked on a regular basis and properly sealed to prevent leakage and deterioration to roof sheathing.

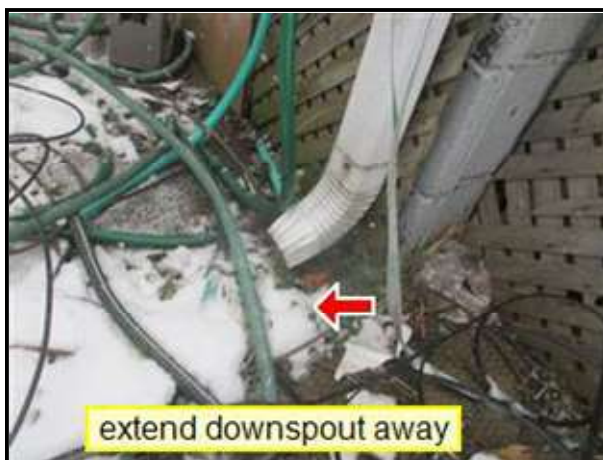
1.6 Picture 1

**1.6** Some downspouts end close to house. Recommend extend downspouts to move water away from the foundation. This will divert roof water away from the foundation and prevent ponding which will reduce the risk of seepage in the basement.

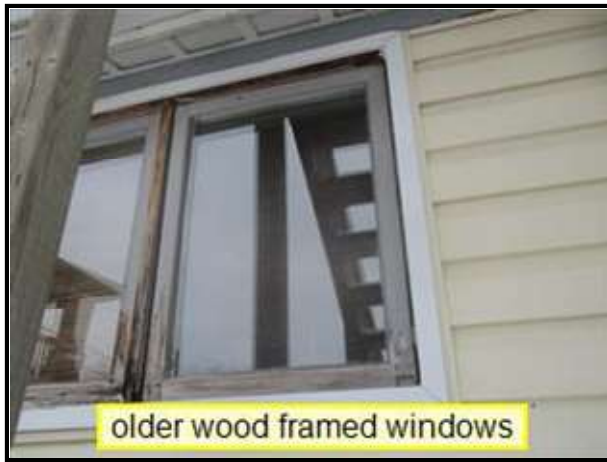
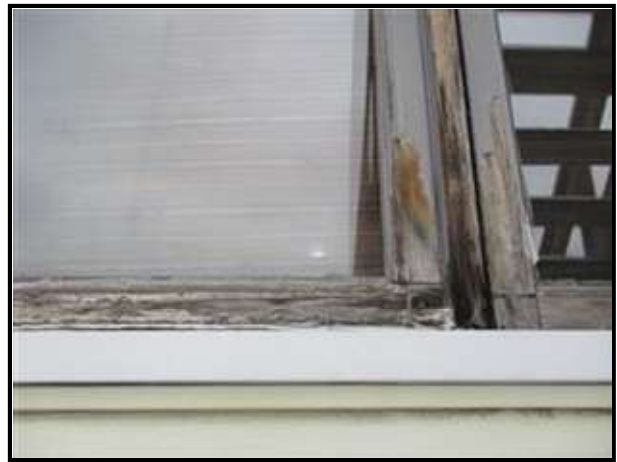
**2.2** Most windows were vinyl replacements, although there were a couple old wood windows in the rear that requires paint for protection from the elements. No decayed wood was found.

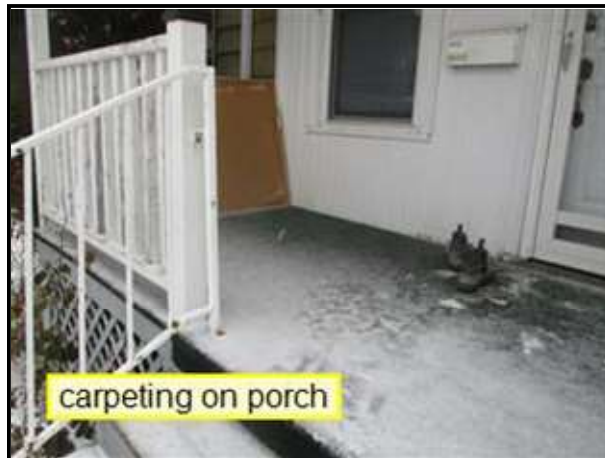
2.4 Picture 1

**2.4** Porch covered in carpet and not visible for full inspection. Exterior carpeting will prevent moisture from drying quickly and can accelerate the decay of the materials. Removing the carpet will help extend the life of the porch.

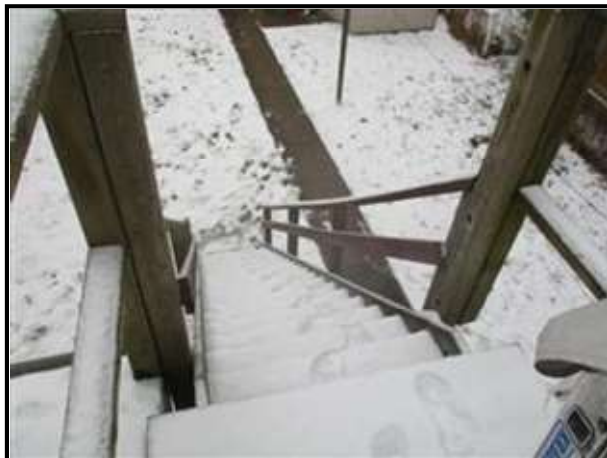
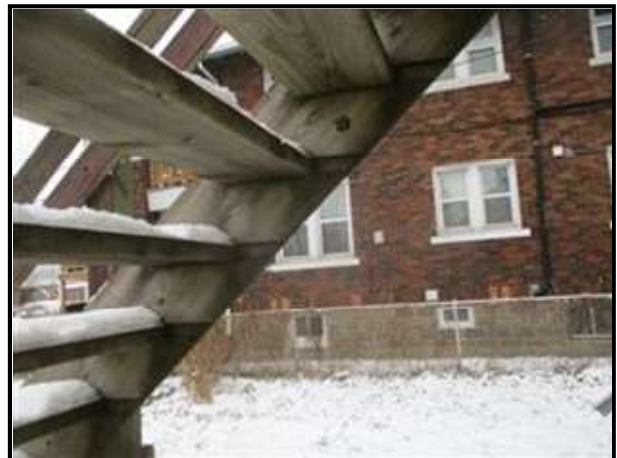
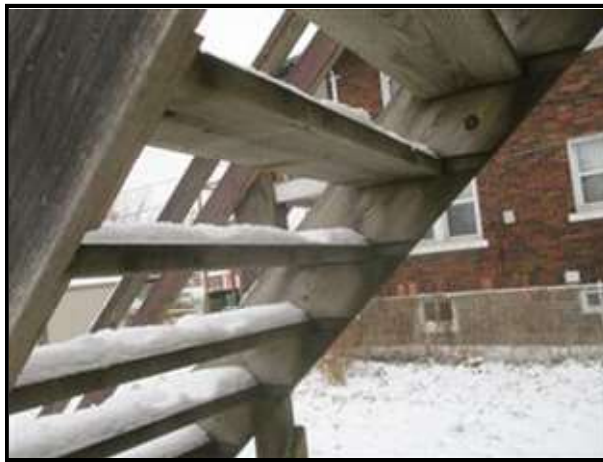
**2.5** Old steps with no visible defects.

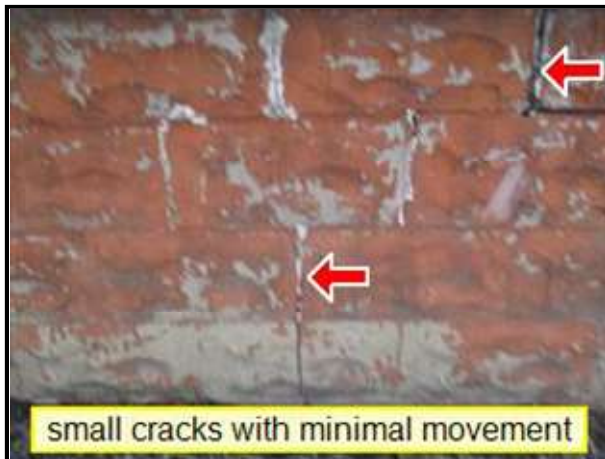
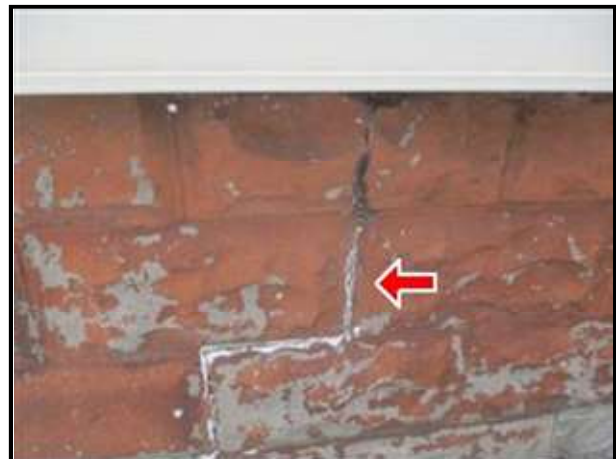
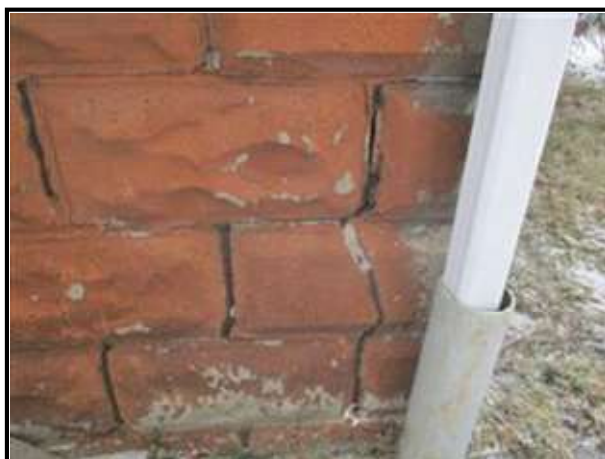
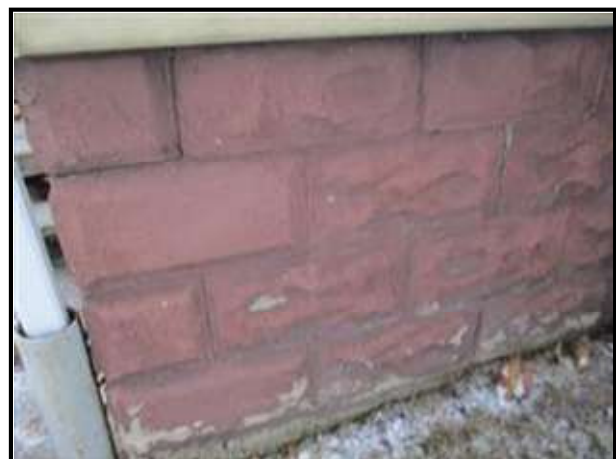
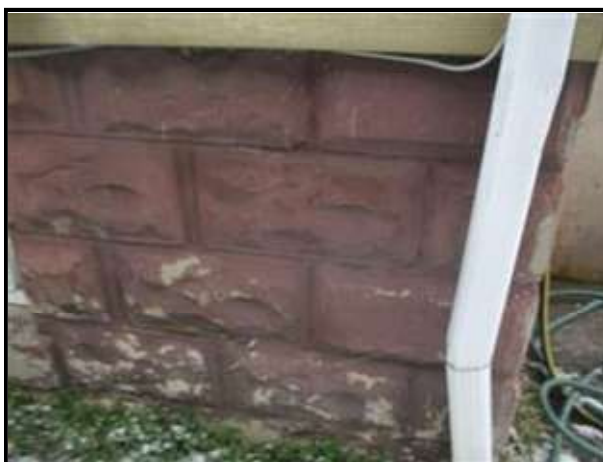
**2.7** Some small cracks noted with no apparent structural affect. It should be noted that any opening has the potential for leakage and a greater emphasis on water management outside, including roof drainage systems, is required to help prevent seepage.

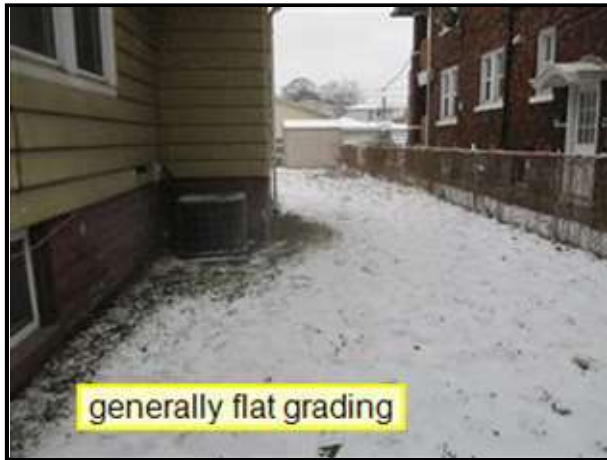
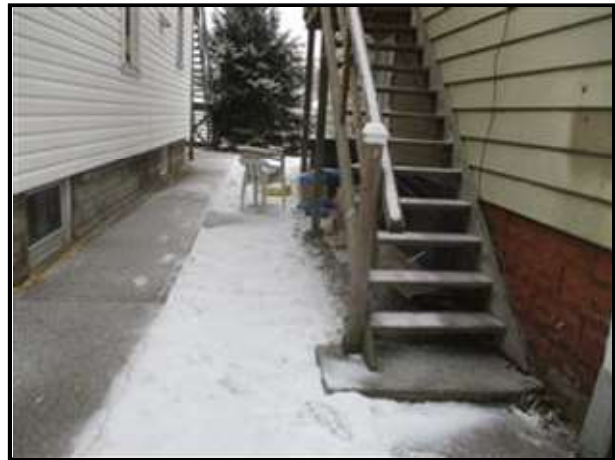
**3.1** Generally flat grading near the foundation.

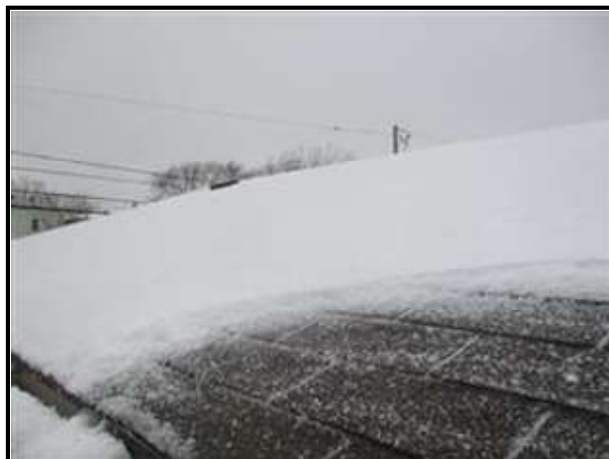
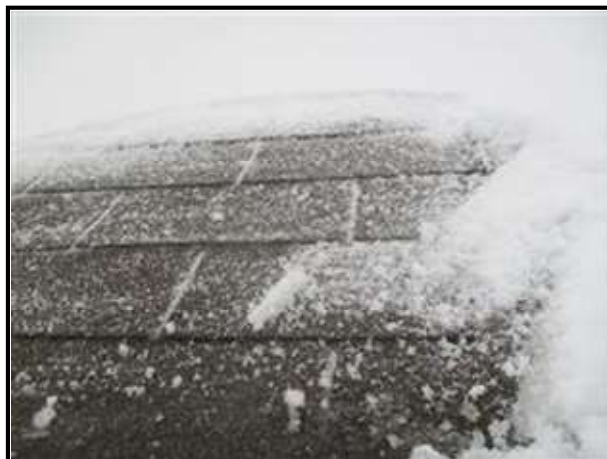
**4.0** Snow covered and not visible at time of inspection. Areas that were cleared away, showed no defects and were in the age group indicated above. Entire roof should be inspected when clear of snow.

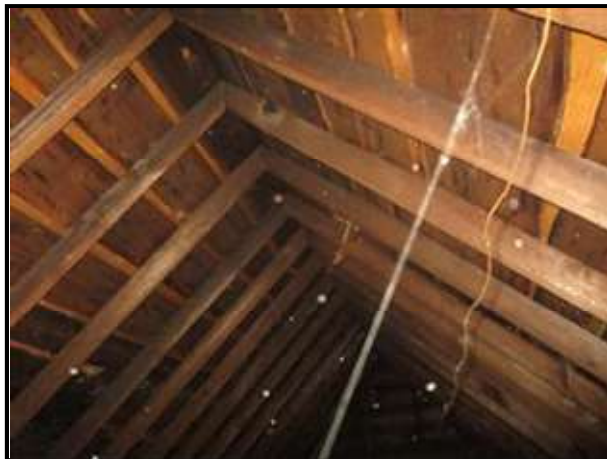
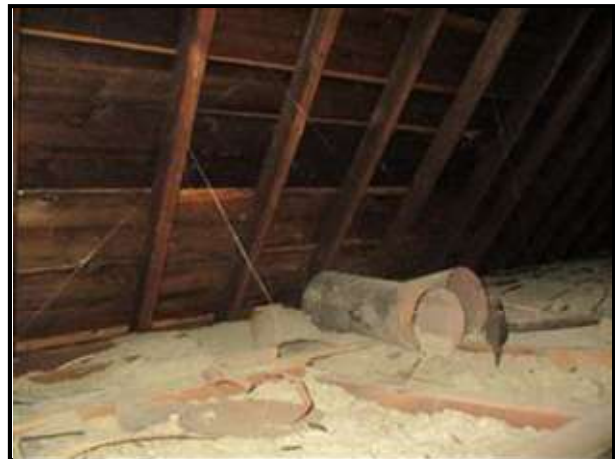
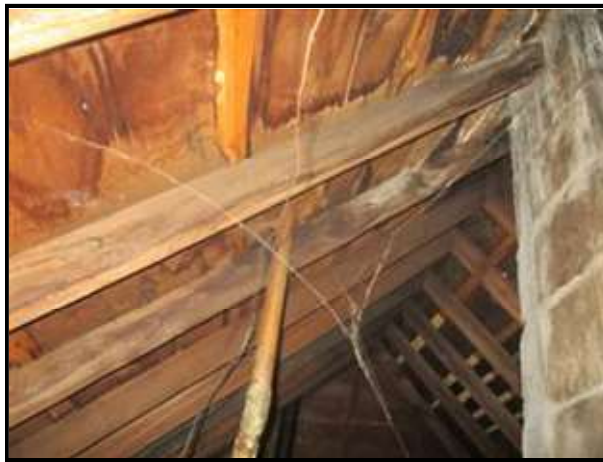
**5.0** (1) 2x4 framing noted, typical of older construction although undersized by today's standards. No unusual sagging of rafters noted, although addition of collar ties or knee walls will reduce the stress on rafters if sagging becomes an issue.

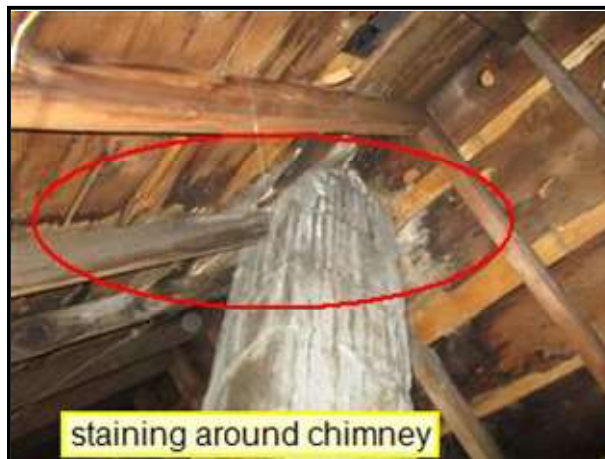
5.1 Picture 1

**5.1** Some staining noted around the chimney from prior leaks. Maintaining a good flashing and seal around the chimney is important to prevent ongoing leakage and damage to the framing/sheathing.

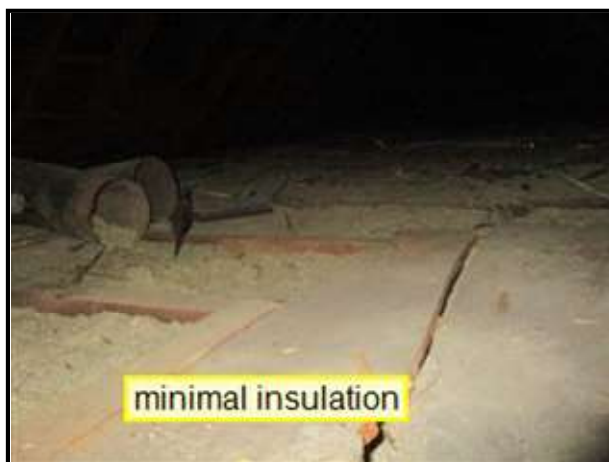
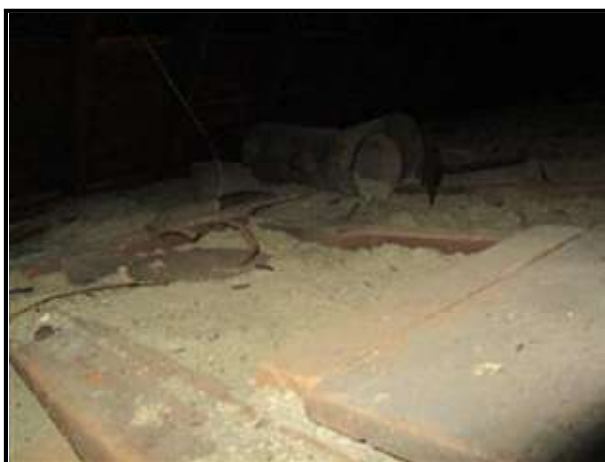
**5.3** Minimal insulation noted; recommend adding adequate insulation for efficiency improvements. Be careful not block soffit vents with additional insulation, as discussed during the inspection.

Limited insulation levels can also create condensation issues. The rising warm air will create condensation if quickly entering into an attic. Increased insulation levels will help slow down the rate of transfer into the attic and can help reduce the risk of condensation and possible mold.

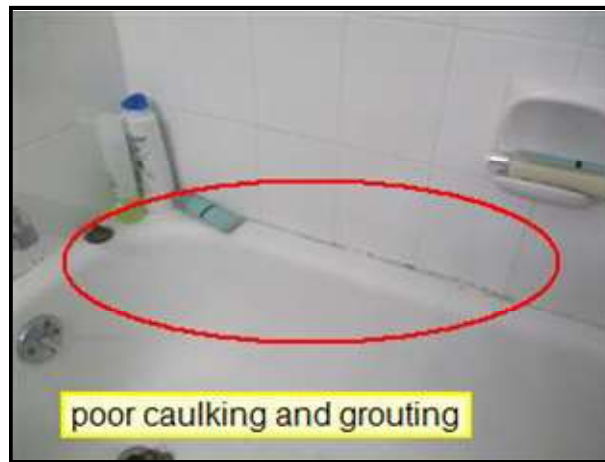
6.3.A Picture 1

Caulking and/or grouting work is required to maintain the watertightness of tile and the tub/shower enclosures. Check for substrate damage if surface damage or leakage is present, and when performing regular maintenance.

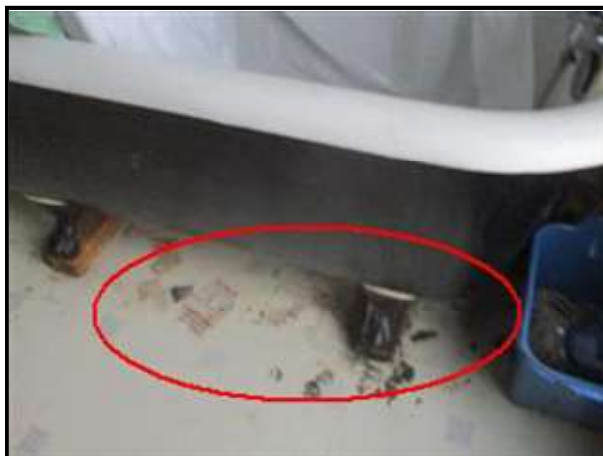
## 6.4.B Picture 1

**6.4.B** Old vinyl with staining throughout. Replace as needed.

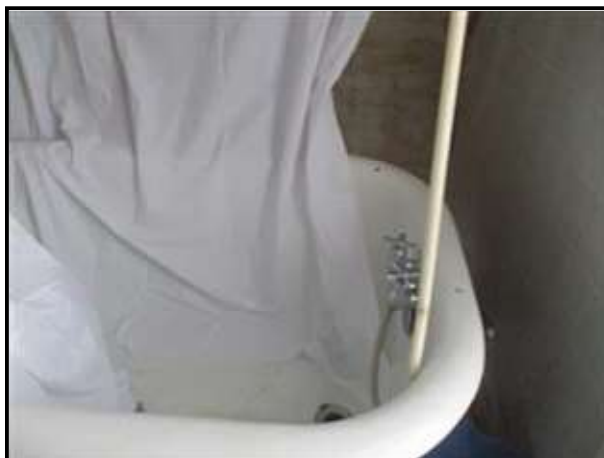
6.5.B Picture 1

**6.5.B** Peeling paint and some mold/mildew noted. Widespread pattern would indicate condensation and not a roof leak. Using the window or installing a ventilator to exhaust warm moist air will help reduce condensation.

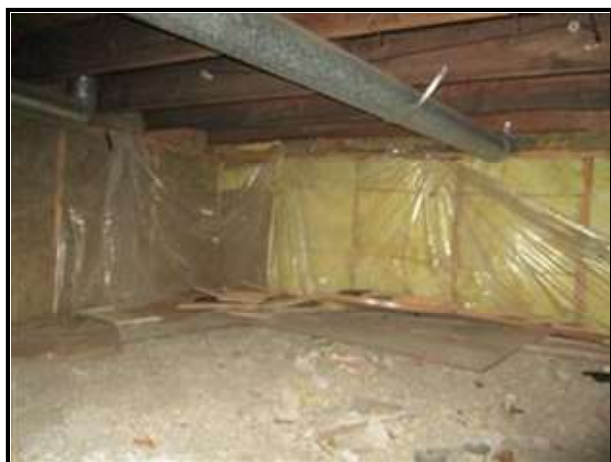
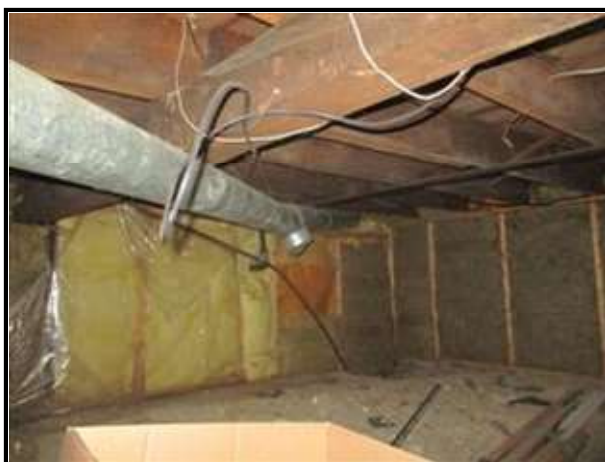
**9.0** (1) Basement mostly covered in finish materials. All comments and ratings are related to visible sections only.

(2) Old foundation walls in typical condition for its age.

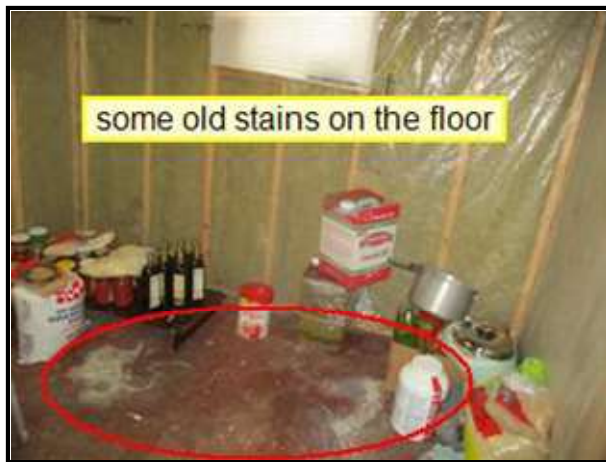
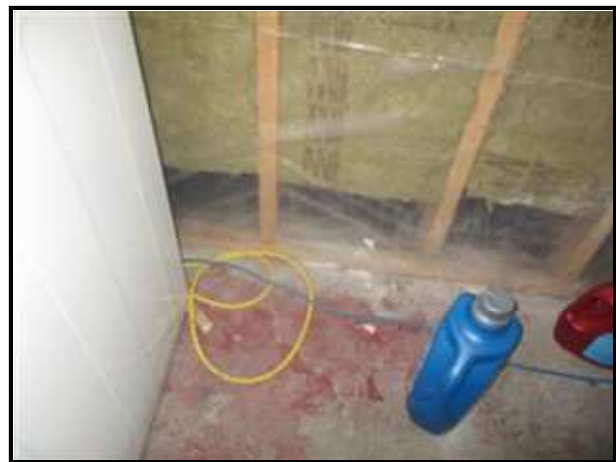
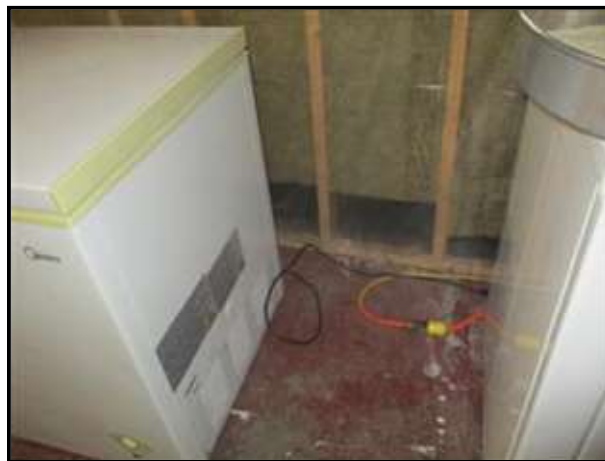
**10.1 (1)** Water stains (efflorescence) noted from prior water penetration; monitor for severity and correct as required. Note: It is not possible to determine when water penetration may have occurred. Sometimes the source of the original water leaks have been addressed. It is difficult to determine if future concerns will occur in the same areas as the water marks from previous leaks.

No signs of current leakage at time of inspection.

(2) Tests with a moisture meter along all outside finished walls did not detect any signs of high moisture levels anywhere. Although this is not a conclusive test, it does provide an opportunity to detect any moisture that might be present and not visible at the time of the inspection.

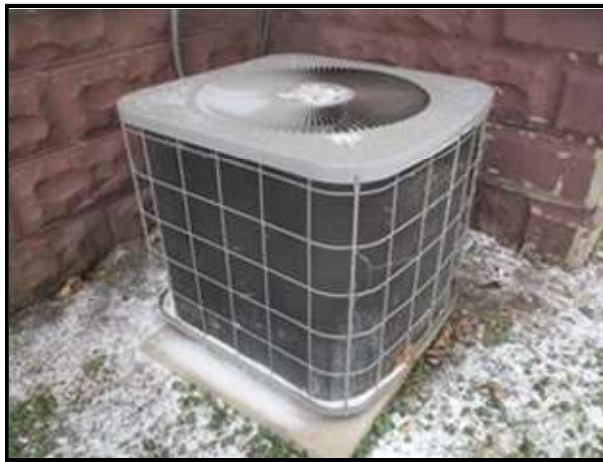
12.1 Picture 1

**12.1** The outdoor unit should be covered in the off season to help protect the inside components from leaves & debris. Covering the top only is recommended and only when there are mature trees in the area. The reason to cover an air conditioner is to help prevent leaves and debris from collecting inside. Covering an air conditioner too well will result in trapping moisture and causing premature wear to the exterior components.

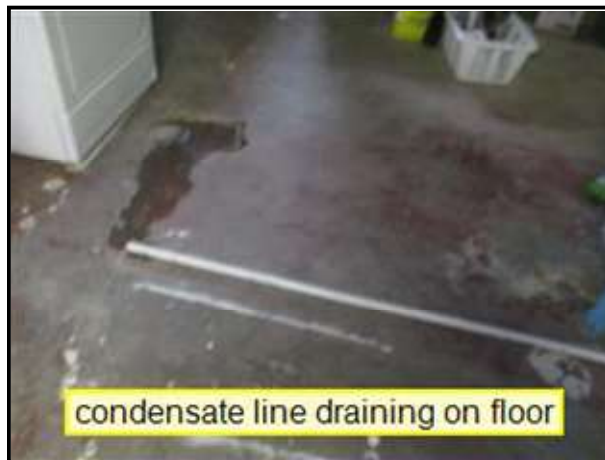
12.2 Picture 1

**12.2** Condensate is a cpvc pipe draining into the floor drain. consider upgrading to a condensate pump as discussed at time of inspection.

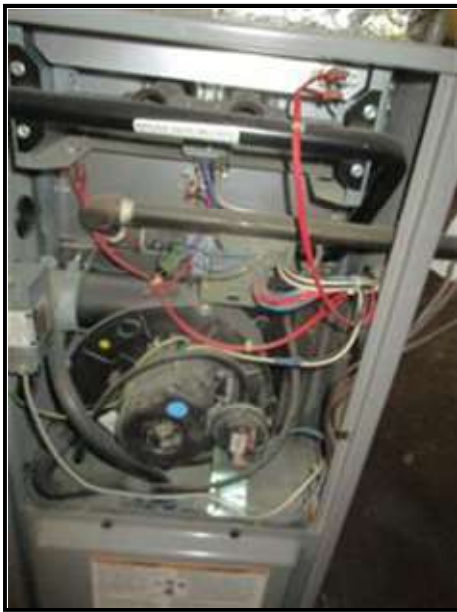
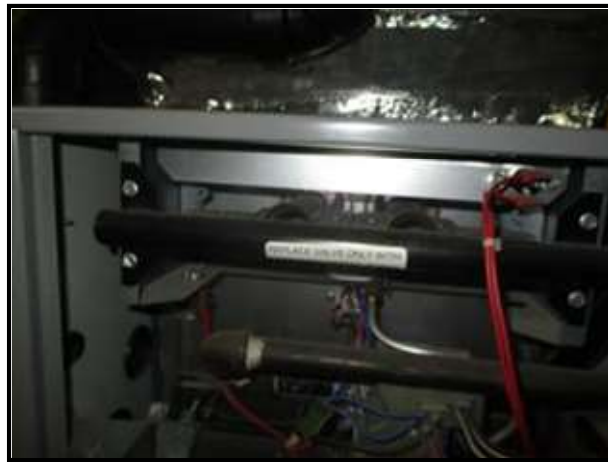
**13.0** (1) High efficiency heating units operate at lower exhaust temperatures; therefore, proper venting and condensate drainage provisions are critical to service life and function. Each unit's requirements vary and cannot be readily assessed during a standard inspection. Clogged condensate lines are a common occurrence with a high efficient unit. While there may not have been any signs of an existing condensate leak at the time of inspection, this can develop with normal use. Check inside the cabinet door when changing or replacing filters as discussed during the inspection and have any condensate leak addressed immediately by a qualified HVAC contractor.

(2) Older unit, although operated without any difficulty for the inspection. Older units can exceed their design life, although these units are more prone to higher maintenance costs and will eventually require replacement. Annual maintenance by a qualified heating contractor is recommended. Carbon monoxide detectors should be installed on each floor of the house as a precaution. Consider upgrading to a more energy efficient system.

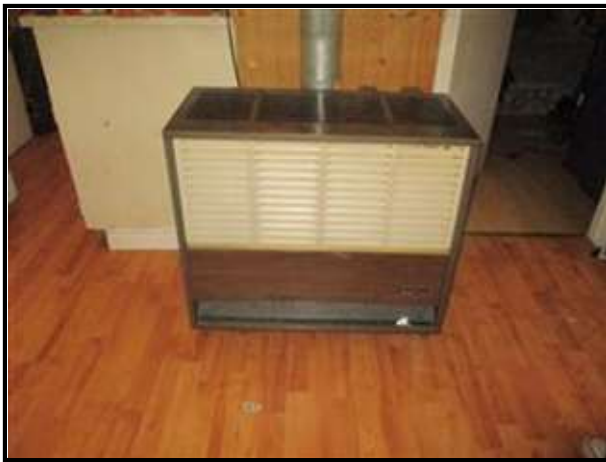
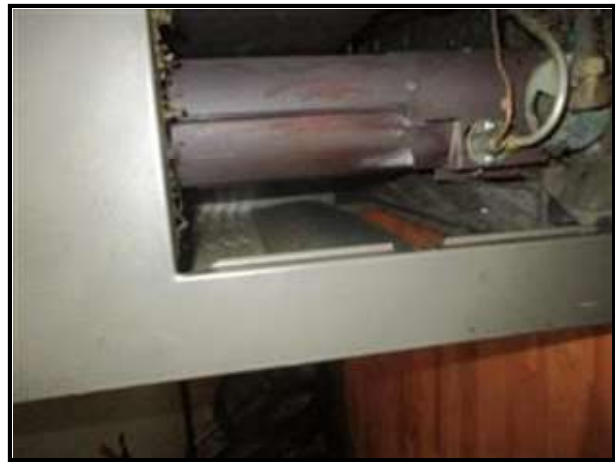
Note: This is a central heating system with no ductwork to individual rooms. Heating will be uneven throughout the floor.

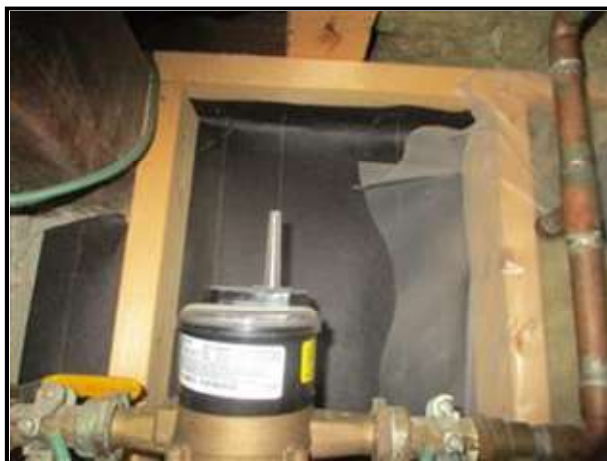
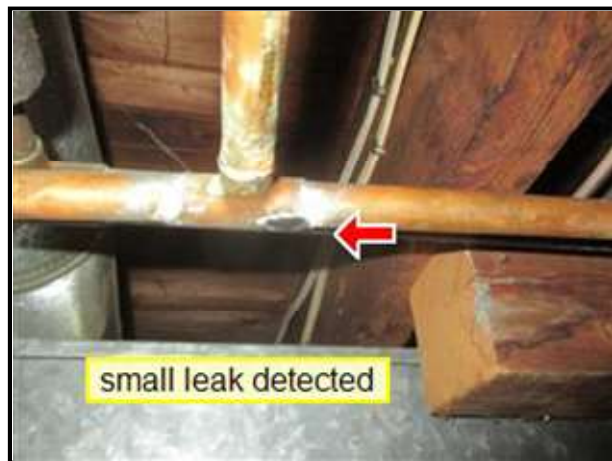
**14.0** All visible piping in the house was updated to copper, although there was a small leak at one of the soldered joints that requires repair.
