AmeriSpec Inspection Service
Tecumseh, Ontario
Ph#: (519) 739-1010 Fax#: (519) 739-1016

Doc #: 112221DC50 Inspector: Donald Campbell
Date: 11/22/2021
Dwelling Address: 3071 Centennial
Windsor, Ontario

AmeriSpec General Home Inspection**GENERAL CONDITIONS**

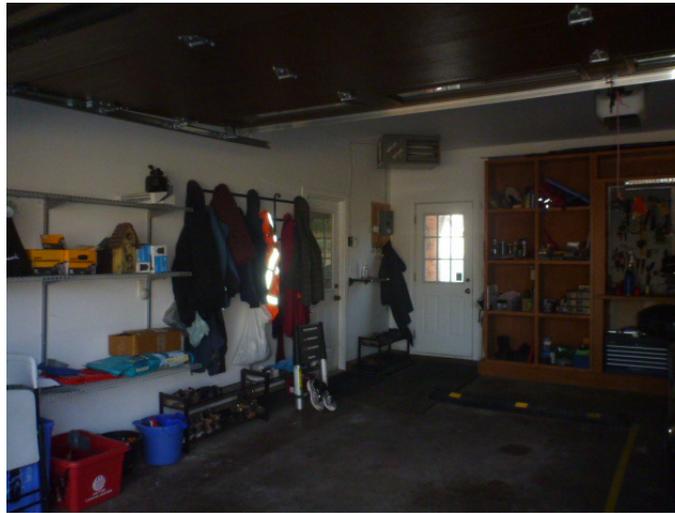
Step #	Component Type	Comment
1301.		Attached garages in most jurisdictions should be separated from common walls of the house by a proper fire wall and fire door. This is to keep the migration of any smoke or fire from entering the house in the event of a fire in the garage. A self closer on the fire door between the garage and the house is an additional safety precaution.
1302.	Exterior	Garage is attached to house. See exterior conditions #1103.
1303.	Methods Used To Inspect Roof	Garage/Carport is attached to house and was inspected the same as in step # 1201.
1304.	Roof Material/Type	Same as house roof material in step #1202.
1305.	Roof Conditions	See roof conditions # 1205.
1306.	Gutters / Downspouts	See exterior comments # 1107.
1307.	Floor/Slab	Concrete.
1308.	Garage Doors	Metal. Garage doors are the heaviest moving part in a home, therefore extreme care must be taken to ensure safe and proper operation.

1311. Fire Door **Review. No self-closer observed. Suggest installing self-closer as a safety measure. Recommend installing a solid-core fire rated door for safety.**

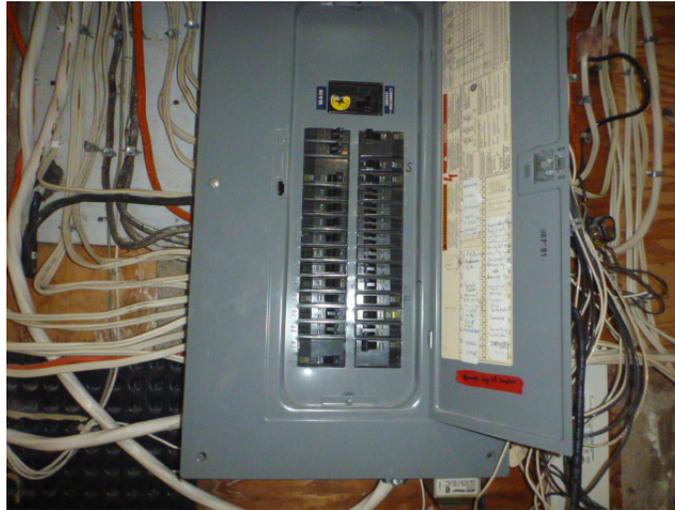
Step #	Component	Comment
1801.	Electrical Main Service	Service entrance is underground.
1802.	Equipment Grounding Present	Yes.
1803.	Main Electrical Panel & Location	Branch circuit wiring is copper; No futures available for expansion. Overload protection is provided by breakers.
1804.	Wiring Method	Romex.
1806.	Smoke Detectors	Periodic testing is suggested to ensure proper working order.

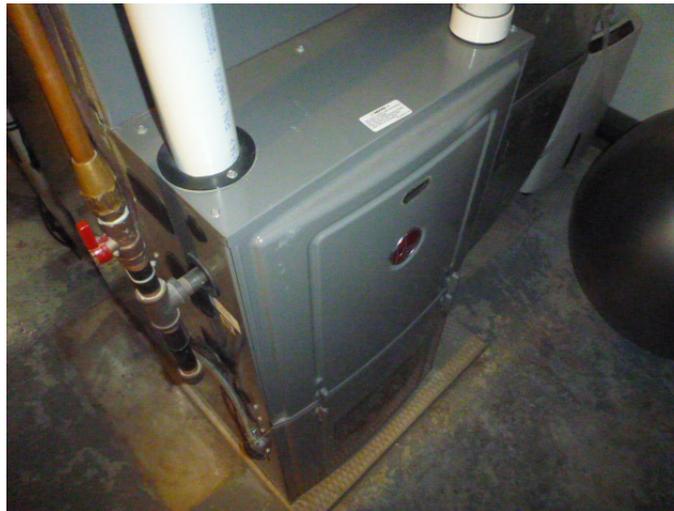
Step #	Component	Comment
1901.	Location of unit	The heating system is located in the basement and services the entire home.

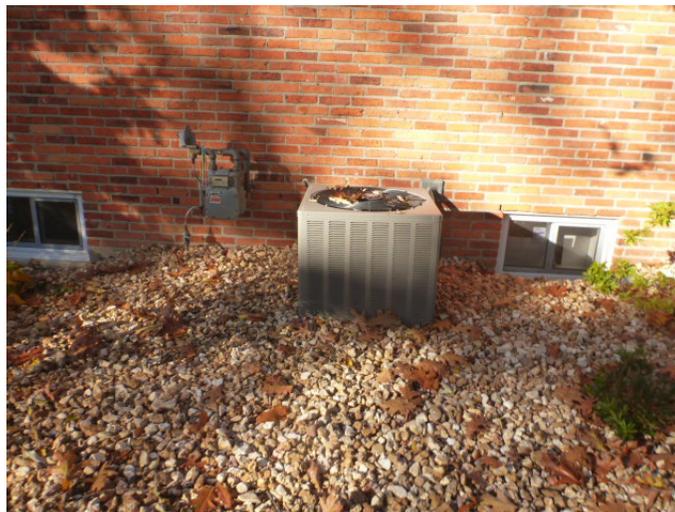
Step #	Component	Comment
2001.	Location of unit	The Air conditioning compressor is located at/on the exterior left, with the A-coil located in/on the basement and services the entire home.
2002.	Air Conditioning Design Type/Brand	Split system; Electric.
2003.	General Conditions	As most manufacturers warn against operating air conditioning units when the outside temperature is below 60 degrees, this unit was not tested. Recommend referring to the Sellers Disclosure Statement regarding the condition of this unit.
2005.	Energy Source	Electric with disconnect provided.

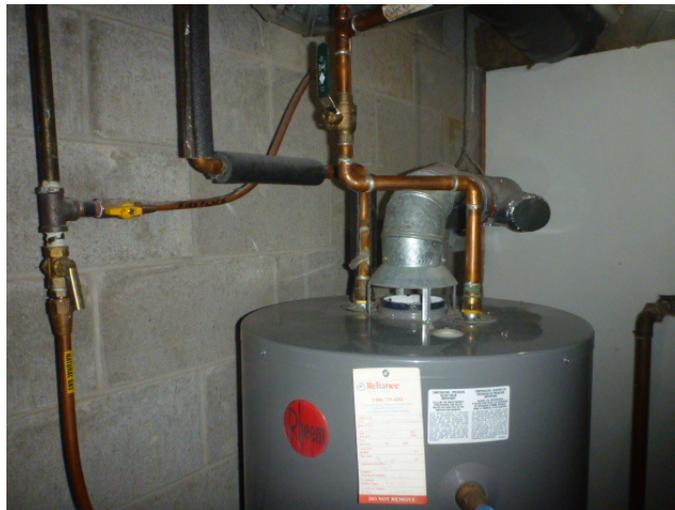
Step #	Component	Comment
2101.	Location of unit	The water heater is located in the basement.
2102.	Water Heater Design Type	Natural gas.
