**AmeriSpec Inspection Service**  
Tecumseh, Ontario  
Ph#: (519) 739-1010 Fax#: (519) 739-1016

Doc #: 051723DC23 Inspector: Donald Campbell  
Date: 5/16/2023  
Dwelling Address: 170 Pentilly  
Tecumseh, ON

## AmeriSpec General Home Inspection

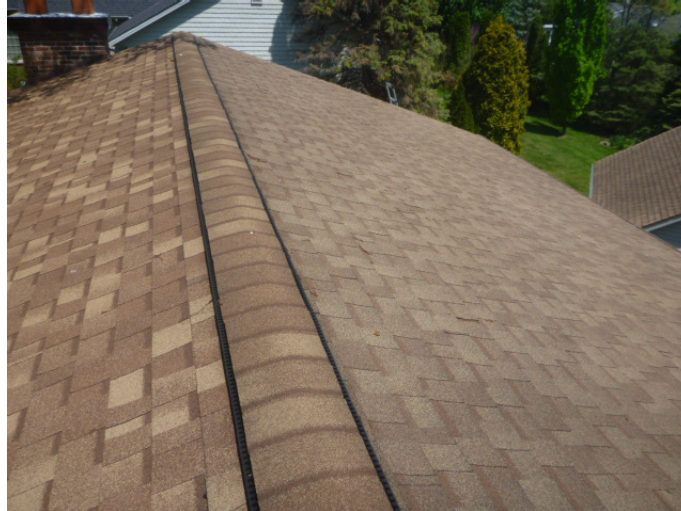
Step #	Component	Comment
1201.	Methods Used To Inspect	The roof was inspected from atop the roof.
1202.	Material/Type	Asphalt composition shingle; Rolled composition roofing.
1203.	Exposed Flashings	<b>Review. Recommend re-sealing all flashings and through the roof vents as a part of routine maintenance.</b>

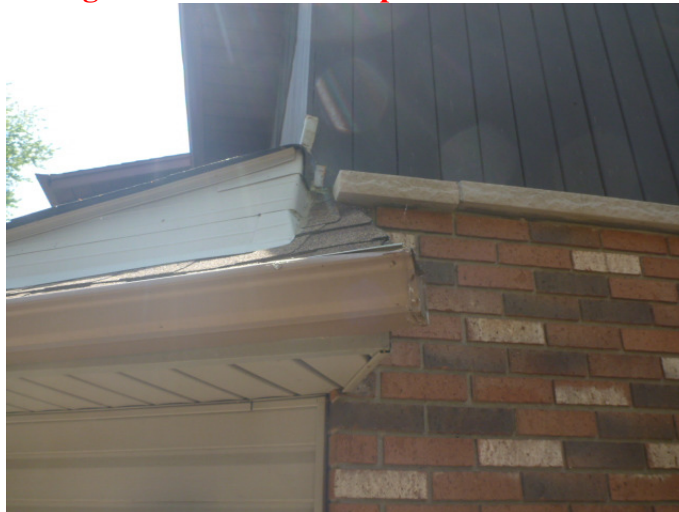
1205.	Conditions	Roof shows normal wear for its age and type. No damaged, deteriorated, or missing roofing materials were observed; it appears to be in serviceable condition at time of inspection.
-------	------------	---

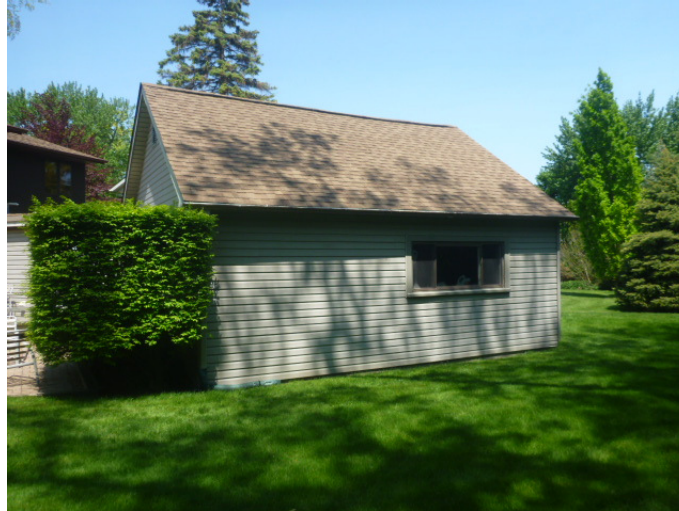
Step #	Component Type	Comment
1301.	Type	Attached garages in most jurisdictions should be separated from common walls of the house by a proper fire wall and fire door. This is to keep the migration of any smoke or fire from entering the house in the event of a fire in the garage. A self closer on the fire door between the garage and the house is an additional safety precaution.
1302.	Exterior	Siding on this home/garage is covered with metal/vinyl. The inspector is unable to view the condition of covered areas. It is important to keep siding well caulked and sealed to prevent moisture penetration
1303.	Methods Used To Inspect Roof	The garage roof was inspected from the the ground and the house roof.
1304.	Roof Material/Type	Asphalt composition shingle.
1305.	Roof Conditions	Roof shows normal wear for its age and type and appears to be in serviceable condition at time of inspection.
1306.	Gutters / Downspouts	See exterior comments # 1107.

**Review. No self-closer observed. Suggest installing self-closer as a safety measure.**

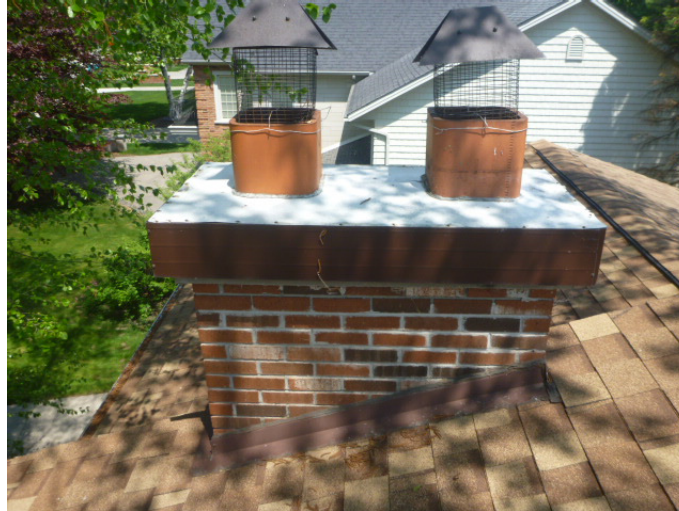
Step #	Component	Comment
1401.	Chimney Type	Masonry chimney.
1402.	Visible Condition	Suggest sealing chimney cap (chimney crown) to reduce opportunity for water infiltration and damage. This is a common maintenance item that is often neglected by homeowners; you should make a crown inspection part of your routine seasonal maintenance checklist.
1403.	Chimney Flue	Clay.
1404.	Flashings	<b>Review. Re-seal as routine maintenance to ensure leak free conditions.</b>

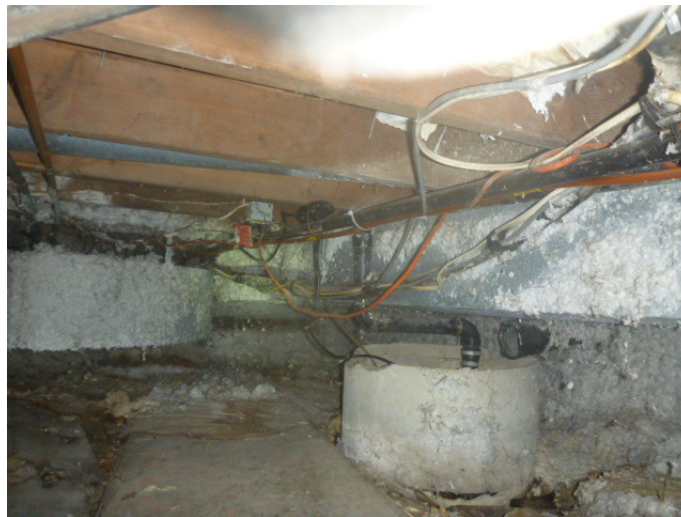
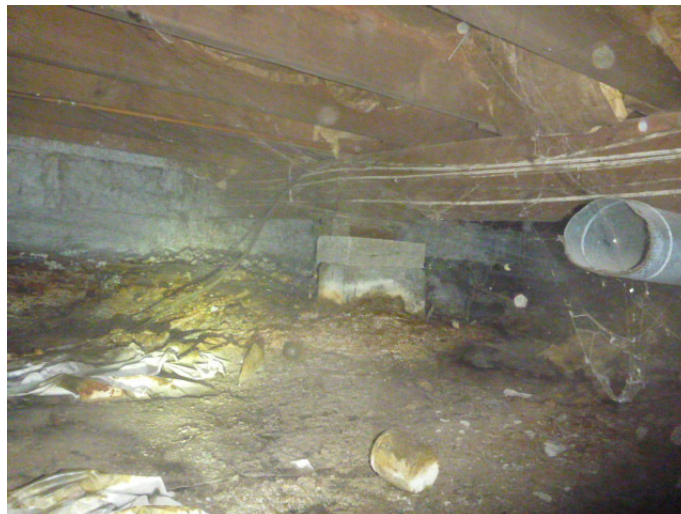
<b>Step #</b>	<b>Component</b>	<b>Comment</b>
1502.	Floor	<b>Review. Dirt. Damp at time of inspection. Suggest extending downspouts and re-grading at exterior to limit further moisture intrusion into the crawlspace.</b>

**Review. No moisture barrier observed. Moisture barriers may not have been required at the time the home was built. Due to moisture problems observed, we suggest installation of a moisture barrier to prevent any future/further damage/deterioration to the structure and to ensure a dry clean crawlspace.**

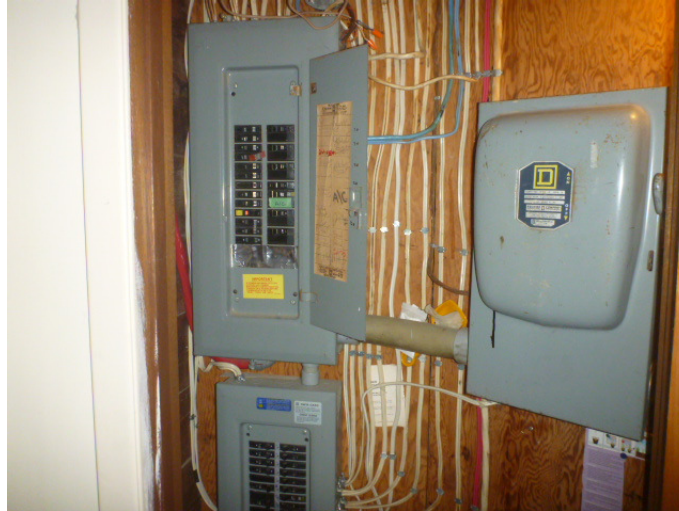
Step #	Component	Comment
1801.	Electrical Main Service	Service entrance is underground.
1803.	Main Electrical Panel & Location	Overload protection is provided by breakers.
1804.	Wiring Method	Romex.
1806.	Smoke Detectors	<b>Review. In the inspectors opinion the smoke detector(s) are near the end of their useful life due to age and condition. Recommend replacement to ensure safety.</b>

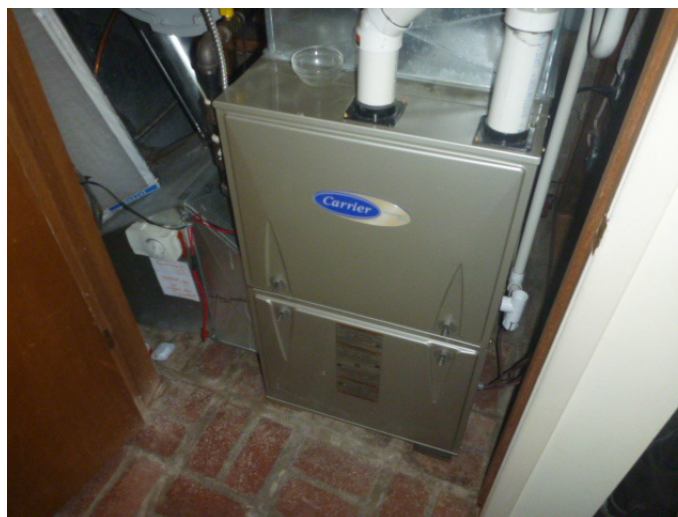
Step #	Component	Comment
1901.	Location of unit	Manufactured in 2014. The heating system is located in the utility room and services the entire home.
1902.	Heating System Design Type/Brand	Gas forced air.
1903.	Energy Source	Natural gas.
1904.	Burner Chambers	Unable to inspect heat exchanger due to closed system.

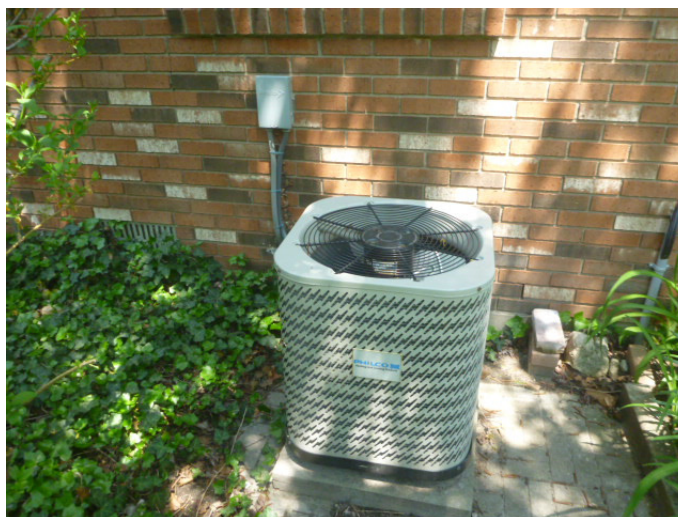
Step #	Component	Comment
2001.	Location of unit	Manufactured in 2011. The Air conditioning compressor is located at/on the exterior right, with the A-coil located in/on the utility room and services the entire home.
2002.	Air Conditioning Design Type/Brand	Split system; Electric.
2003.	General Conditions	As most manufacturers warn against operating air conditioning units when the outside temperature is below 60 degrees, this unit was not tested. Recommend referring to the Sellers Disclosure Statement regarding the condition of this unit.
2005.	Energy Source	Electric.
2008.	Distribution / Ducting	Ducts/Registers. Efficiency and load calculations are beyond the scope of this inspection and expressly omitted from this report. If a detailed inspection is desired, a licensed heating contractor should be consulted prior to closing to ensure proper operation of this unit.

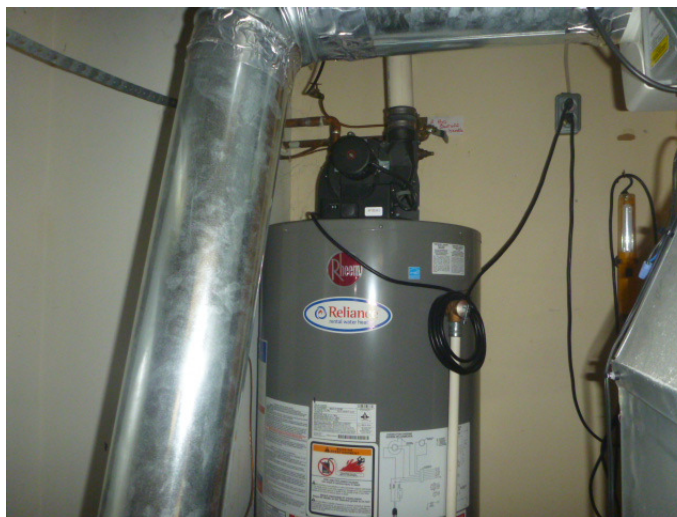
Step #	Component	Comment
2101.	Location of unit	The water heater is located in the utility room.
2102.	Water Heater Design Type	Natural gas.
2104.	Supply Lines	Copper.
2105.	Energy Source	Natural gas.

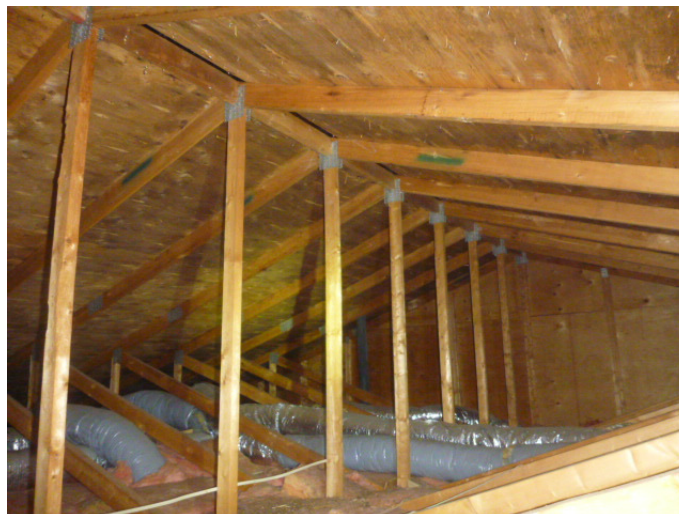
<b>Step #</b>	<b>Component</b>	<b>Comment</b>
2702.	Framing	Trusses. Wood truss construction noted. Trusses are often used to provide additional headroom and wider spans than is common with wood joist systems. This is a specialized system which is intended for site-specific engineering. The integrity of a truss system depends on the builder following a truss engineer's instructions, which we do not have. Verifying appropriate installation is beyond the scope of this inspection. Trusses should not be cut or notched as this will damage their structural integrity.
2703.	Sheathing	Plywood.
2705.	Insulation	Fiberglass.
2706.	Ventilation	Ridge vents; Soffit vents.
2708.	Electrical	Not Inspected.
2712.	Attic Comments	We recommend insuring kitchen/bathroom exhaust fans are exterior vented as routine maintenance.
